Service Bulletin

Bulletin No.: 16-NA-304

Subject: Thump Noise When Changing HVAC Modes

Brand:	Model:	Model Year:		VIN:		Engine:	Transmission:
		from	to	from	to		
Chevrolet	Camaro	2016	2017	SOP	June 6, 2016	All	All

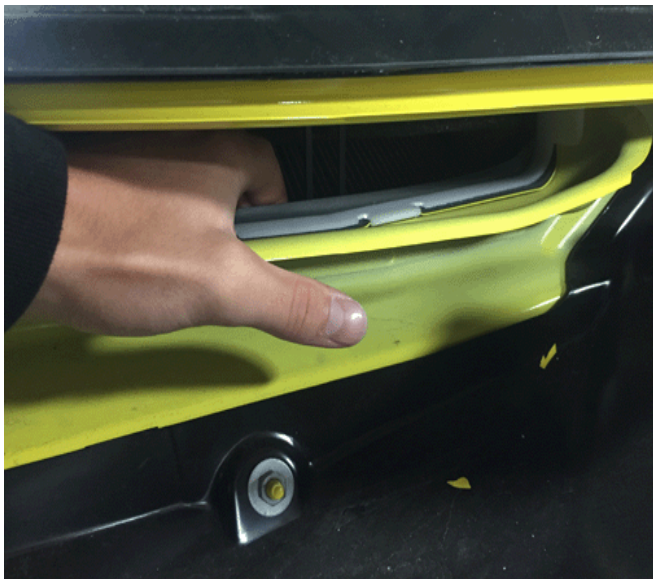
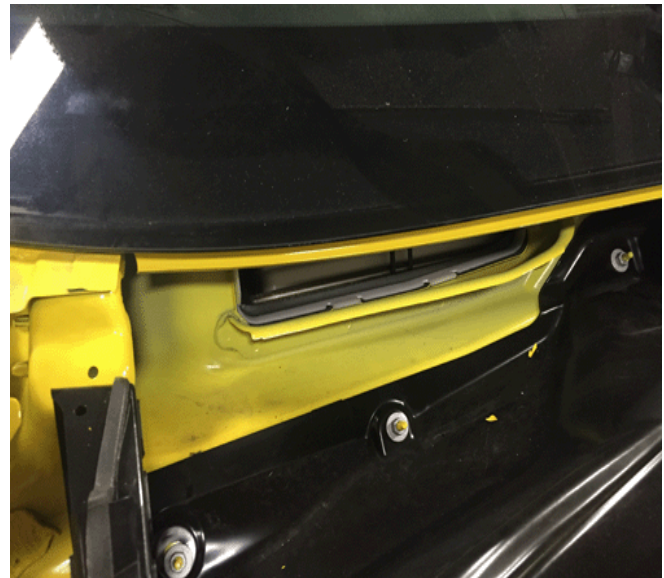
Involved Region or Country	North America, Middle East, Europe, Israel, Argentina, Chile, Colombia, Peru, Brazil and Korea
Condition	Some customers may comment on a thump noise when changing HVAC modes.
Cause	This may be due to stack-up tolerance of components when the recirculation door is cycled.

3. With the plenum water deflector removed, gently pull on the sheet metal on the lower side of the opening for the HVAC recirculation opening.
4. Cycle the recirculation mode on and off to verify that the concern has been corrected. This is best performed with the blower on low and air on face mode. If the noise is still present, repeat Step 3 as necessary.
