Service Bulletin

Bulletin No.: 16-NA-305

Subject: Brake Rotor Cover Removal at Pre-Delivery Inspection (PDI)

Brand:	Model:	Model Year:		VIN:		Engine:	Transmission:
		from	to	from	to		
Buick	Cascade	2017	2017	September 12, 2016	EOP	All	All

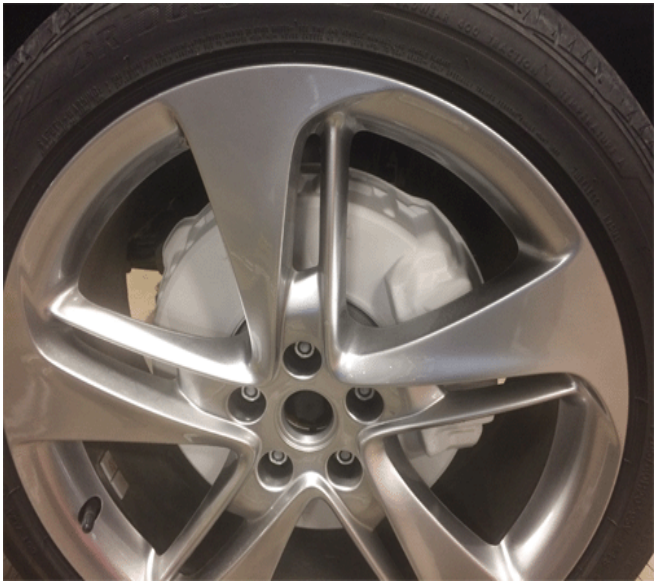
<p style="text-align: right; font-size: small;">4583624</p>
Cause	Brake Rotor covers are being implemented in production that need to be removed during the PDI process. Covers have been implemented to reduce corrosion on calipers and rotors during ocean transport stages.
