Service Bulletin

Subject: Moaning or Vibration Type Buzzing Noise from Under Vehicle

Brand:	Model:	Model Year:		VIN:		Engine:	Transmission:
		from	to	from	to		
Cadillac	ATS	2016	2017				M5U
	CTS				LF4, LT4	UCIVI

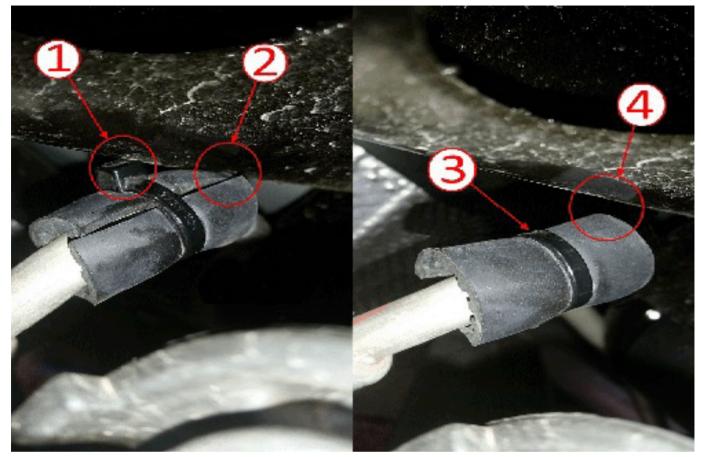
4578819

- 1. Inspect tie straps (1) or bumpers (2) for signs of contact with the vehicle body.
 - The tie straps should be positioned away from the body (3).
 - The cooler line insulators should not contact the body, frame or rear cradle (4).

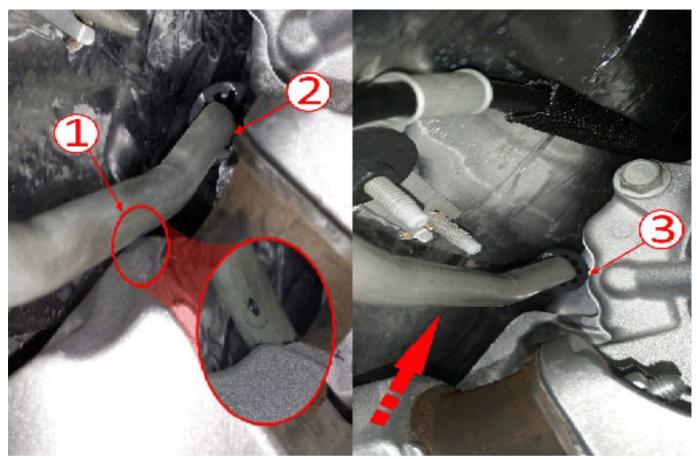
4579275

- 2. Inspect cooler lines for contact to mounts (1) or metal on metal (2).
 - If necessary, install or re-position insulators (3) avoiding metal on metal contact.
 - Position cooler lines allowing for proper clearance as shown on the right.

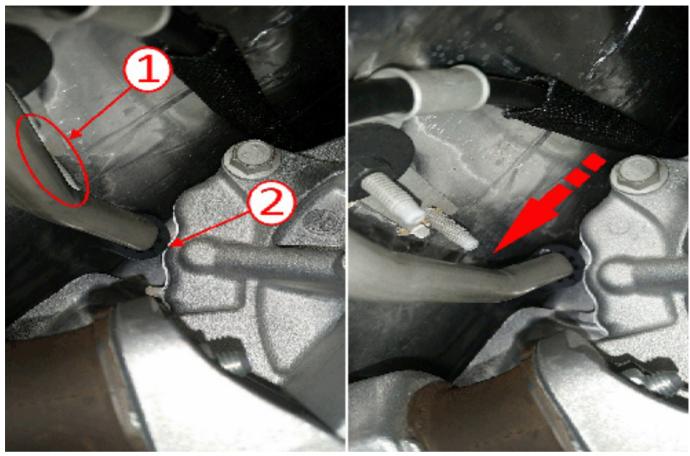
4578950

- 3. Inspect cooler lines for contact with the body or any protruding studs (1).
 - Insulated lines may contact the transmission (2).
 - Position cooler lines away from studs as shown on the right.

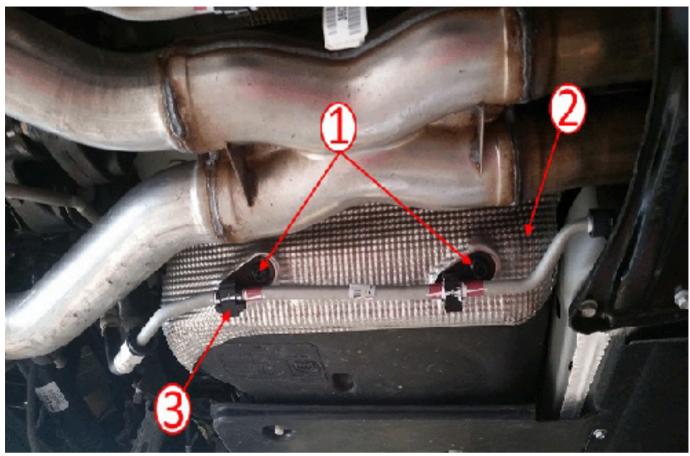
Note: Cooler line clips (3) are held on to a bracket that locks onto a floating style retainer (1), which allows for minimal movement.

- 4. Inspect cooler lines for excessive movement and contact with the body or heat shields (2).
 - Position cooler lines so they do not bind the floating retainer.
 - Verify clips are secured to the cooler lines and retainer brackets.
