Service Bulletin

Bulletin No.: 16-NA-312

Subject: Fuel Contamination - Incorrect Fuel Filler Neck Installation

Brand:	Model:	Model Year:		VIN:		Engine:	Transmission:
		from	to	from	to		
Chevrolet	Low Cab Forward Medium Duty 3500HD	2016	2016			3.0L Turbo/ Intercooled Diesel (RPO IZ3)	
	Low Cab Forward Medium Duty 4500HD/XD- 5500HD/XD	2017	2017			5.2L Diesel (RPO 11B)

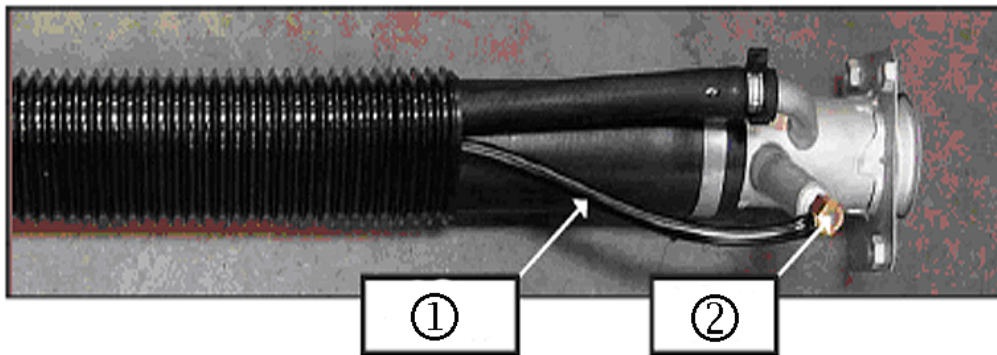
Fuel Filler Neck Assembly

Important: The rollover valve hose (1) must be installed to the rollover valve (2) and routed into the corrugated hose protector in order for the valve to work properly.

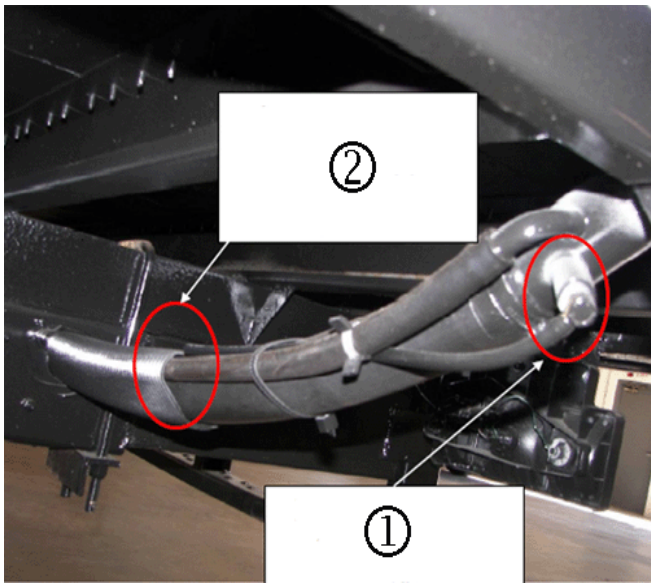
4561598

Fuel filler necks found in these conditions will result in fuel contamination.

Rollover Valve is installed upside down (should point up) (1) and the **Rollover Valve Hose** (2) should terminate inside of corrugated tube as shown in the illustration above.

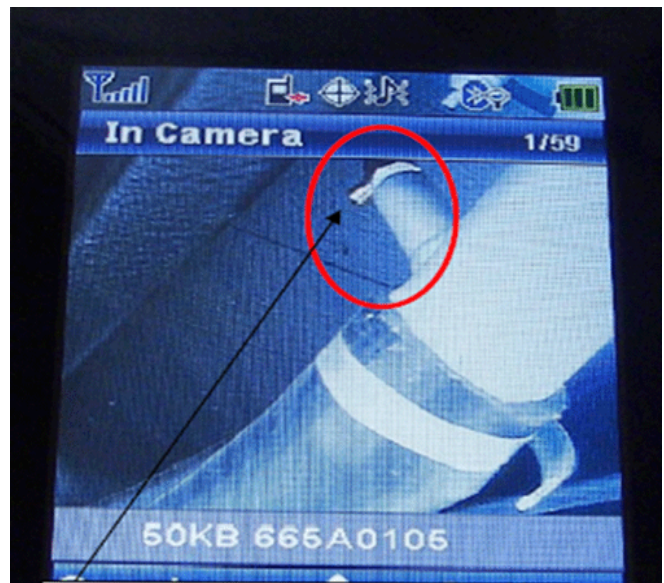
4561604

Rollover Valve Tube is not installed as shown in the illustration above.
