Service Bulletin

Bulletin No.: 16-NA-318

Subject: Hard to Steer in Colder Temperatures and/or Knocking/Clicking Noise Heard

Brand:	Model:	Model Year:		VIN:		Engine:	Transmission:
		from	to	from	to		
Buick	Encore	2013	2016			All	All
Chevrolet	Trax	2013	2016			All	All

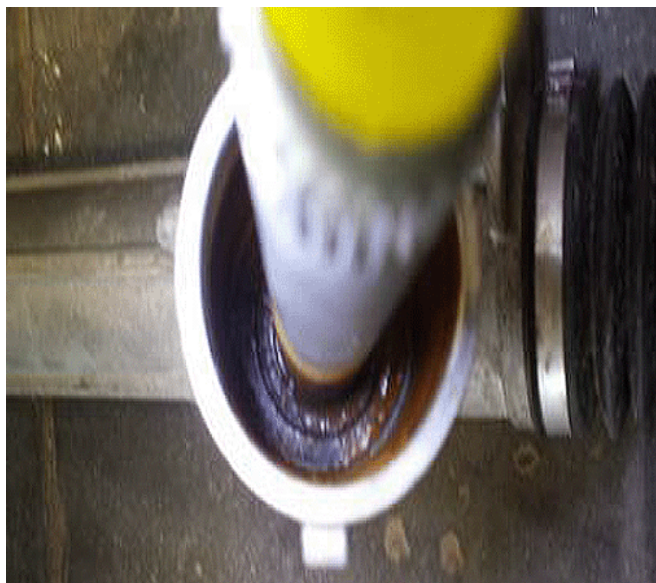
4355408

Check for water intrusion and corrosion at the power steering gear pinion housing. A small amount of rust spots are normal such as one or two small red rust spots.

If water intrusion and/or more than 1 or 2 rust spots is detected, replace both the intermediate steering shaft boots (seals) and the steering gear.
