Service Bulletin

Bulletin No.: 16-NA-319

Subject: Hard to Steer and/or Steering Pulls

Brand:	Model:	Model Year:		VIN:		Engine:	Transmission:
		from	to	from	to		
Buick	Encore	2015	2015	SOP	January 20, 2016		
Chevrolet	Tracker	2015	2015	SOP	January 20, 2016		
Chevrolet	Trax	2015	2015	SOP	January 20, 2016		
Opel	Mokka	2015	2015	SOP	January 20, 2016

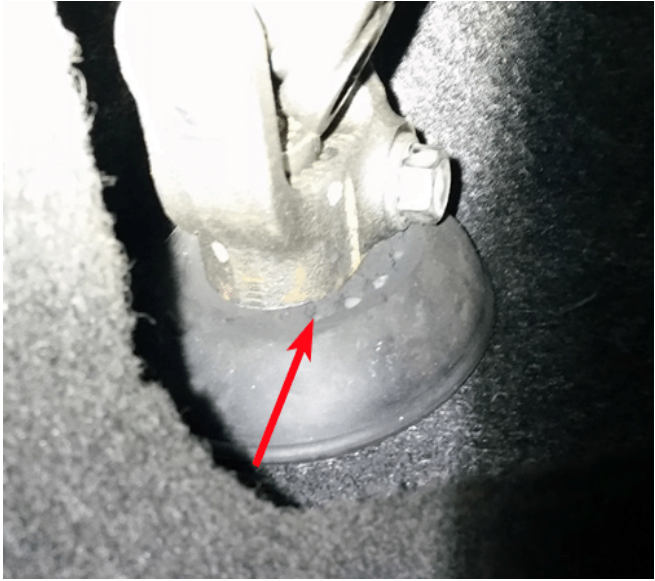
<p style="text-align: right;">4364740</p> <p>This condition may be due to the intermediate shaft steering boot (seal) making contact with the intermediate shaft joint.</p>
Additional Options	STEERING – POWER, NON-VARIABLE RATIO, ELECTRIC (RPO NJ1)
