Service Bulletin

Bulletin No.: 16-NA-322

Subject: HVAC Blows Cold and/or No Heat in Floor Mode

Brand:	Model:	Model Year:		VIN:		Engine:	Transmission:
		from	to	from	to		
Chevrolet	Malibu (VIN Z)	2016	2016

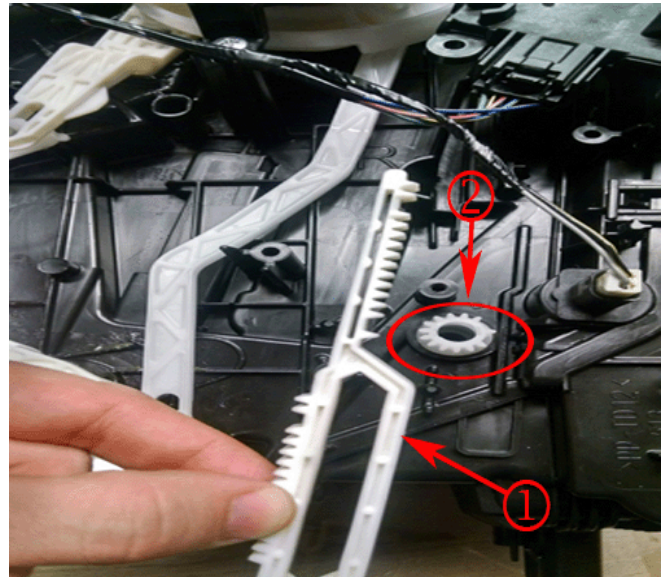
4585791

Note: The illustration shows the location of the upper gear shaft.

4. Remove the wrapped gear rack (1) and gear rack cover (not pictured) and discard them both. **DO NOT** remove the servo (2).

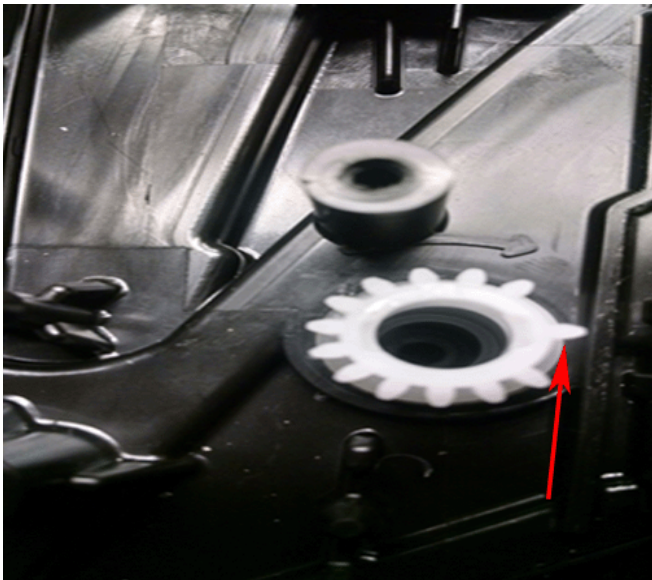
4585795

Note: Inspect to make sure there is no damage to the upper and lower gear shaft teeth.

5. Verify the lower gear shaft is turned to the stop position, as shown by the arrow above.
