Service Bulletin

Bulletin No.: 16-NA-324

Subject: Small Holes Pierced into Sail Panel Area of Folding Top Cover, One/Both Sides

Brand:	Model:	Model Year:		VIN:		Engine:	Transmission:
		from	to	from	to		
Buick	Cascada	2016	2017			All	All

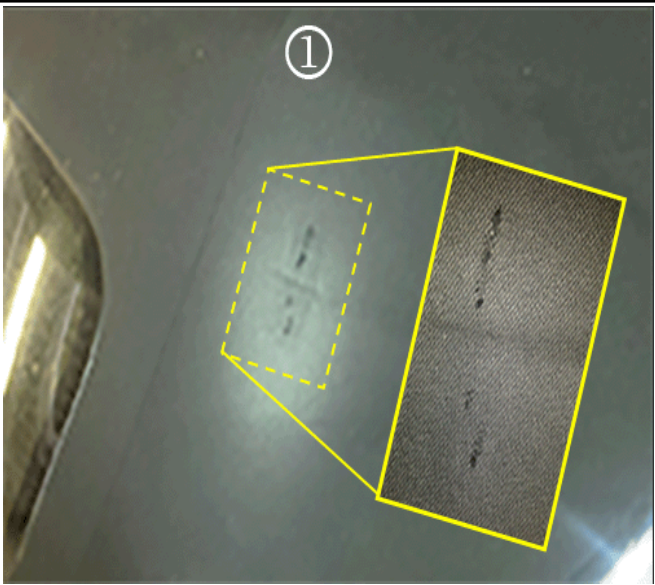
<p style="text-align: right;">4585782</p>

Some customers may comment on seeing small pierced holes appearing in the sail panel area, on one or both sides of the folding top cover. Examples of right side (1) and left side (2) damage are shown in the graphics above.
Cause	The cause of the condition may be tension straps sewn into the top cover that were too long in length. This allowed the top cover material to fold into, and be pinched by, the kinematic hinge causing the wear/damage.

Replace the folding top cover. Refer to *Folding Top Cover Replacement* in SI.
