# Service Bulletin

File in Section: -  
 Bulletin No.: 16-NA-327  
 Date: October, 2016

**Subject:** Instrument Panel (IP) Rattle or Buzz Noise

Brand:	Model:	Model Year:		VIN:		Engine:	Transmission:
		from	to	from	to		
Chevrolet	Cruze (VIN B)	2016	2017			All	All

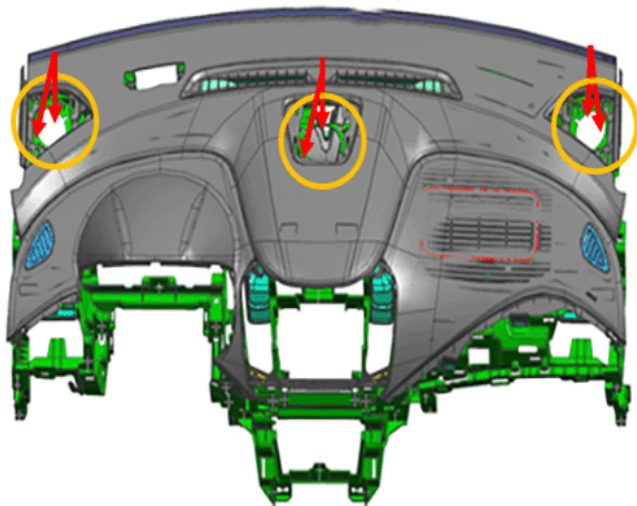
4586937

<b>Involved Region or Country</b>	North America, South America, Israel
<b>Additional Options (RPO)</b>	Equipped with Speaker System - Standard Audio (RPO UQF) or Speaker System - 6, Premium (RPO UZ6)
<b>Condition</b>	Some customers may comment on hearing a rattle or buzz noise from the IP during certain driving conditions, such as rough or dirt roads.
<b>Cause</b>	The cause of the condition may be that for particular radio speaker systems, there may be no speaker mounted in the center and/or right/left side positions in the IP. This may allow the push nuts that normally retain the speaker bolts to rattle when there is no speaker present in that location.

Verify the condition and install bolts to the appropriate IP locations to keep the push nuts stationary. The RPO UQF vehicles will require two bolts for the center position only, the RPO UZ6 vehicles will require six; two per three locations.
