Service Bulletin

Bulletin No.: 16-NA-329

Subject: No Start Condition - Radio Harness Pinched Behind Instrument Control Panel (IPC)

Brand:	Model:	Model Year:		VIN:		Engine:	Transmission:
		from	to	from	to		
Chevrolet	Cruze (VIN B)	2016	2017

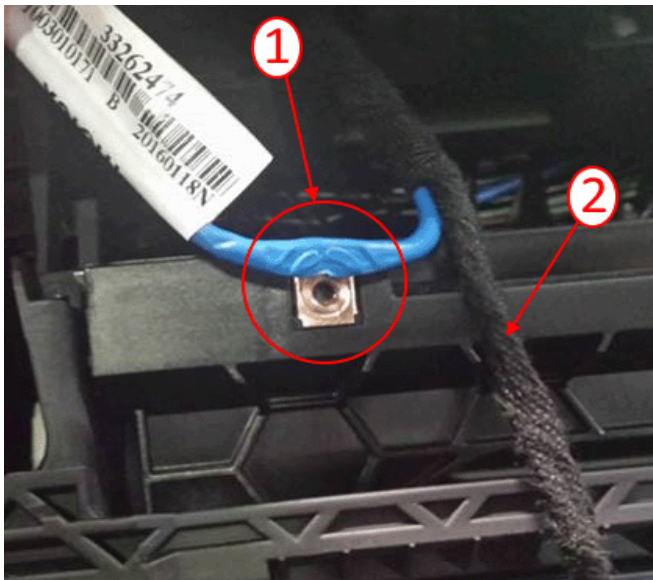
4586946

Involved Region or Country	North America, Israel
Additional RPO	BTM
Condition	Some customers may comment that the vehicle has a no start condition. The Technician may find multiple High and Low speed GMLAN DTCs set.
Cause	This condition may be caused by the radio's GMLAN wiring harness pinched between the radio and the instrument panel.

1. Remove the Radio Control Assembly. Refer to *Radio Control Assembly Replacement* in SI.
 - Inspect the GMLAN wiring harness (2) for any signs of damage (1).
2. Repair the wiring harness. Refer to GMLAN and Media Oriented Systems Transport (MOST) Wiring Repairs in SI.
3. Using care, route the wiring harness away from the IPC and install the radio assembly.
