Service Bulletin

Bulletin No.: 16-NA-333

Subject: Cracked Tail Lamps

Brand:	Model:	Model Year:		Date Breakpoints:		Engine:	Transmission:
		from	to	from	to		
Buick	Regal	2016	2016	April 1, 2016	June 30, 2016	All	All

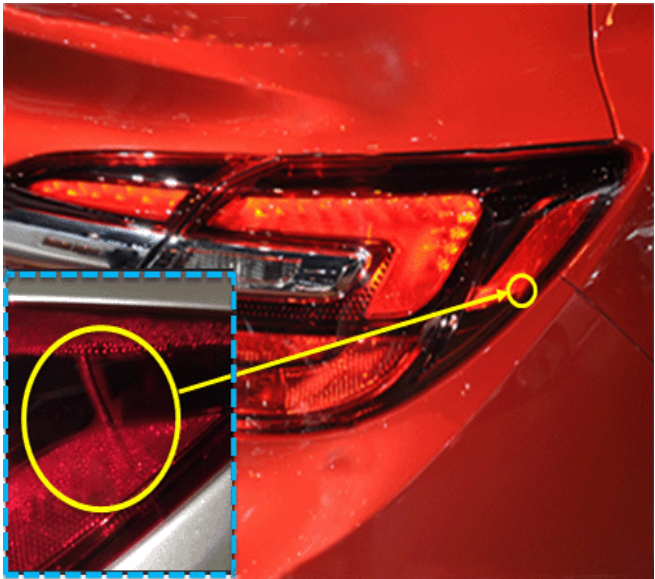
<p style="text-align: right;">4587559</p> <p>Some customers may comment on seeing a crack on the outer lens of the right and/or left tail lamp. In some cases, customers may mention a water leak related to the same area.</p>

Replace the affected tail lamp(s). Refer to *Tail Lamp Replacement* in SI.

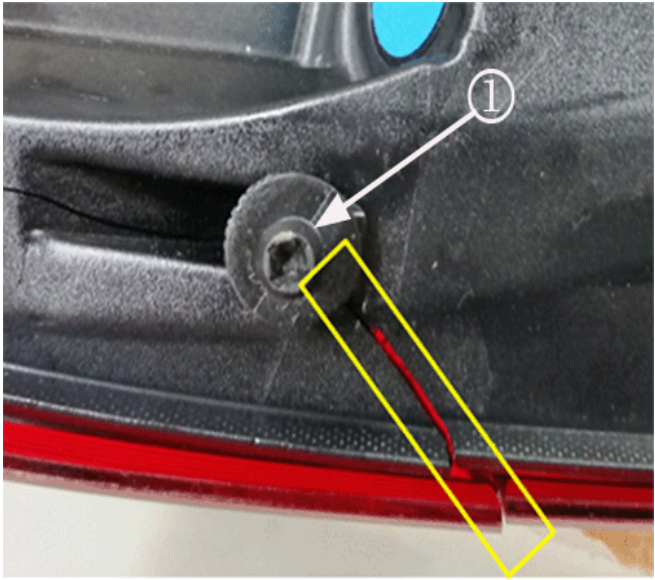
<p>4587563</p> <p>The cause of the condition may be due to a change in the tail lamp fastening process at the plant. The crack often travels through the fastener (1), as shown in the graphic above.</p>
