# Service Bulletin

**Subject:** Popping Noise from Front of Vehicle When Traveling Over Bumps

**Models:** 2013-2015 Cadillac ATS  
2014-2015 Cadillac CTS (VIN A)

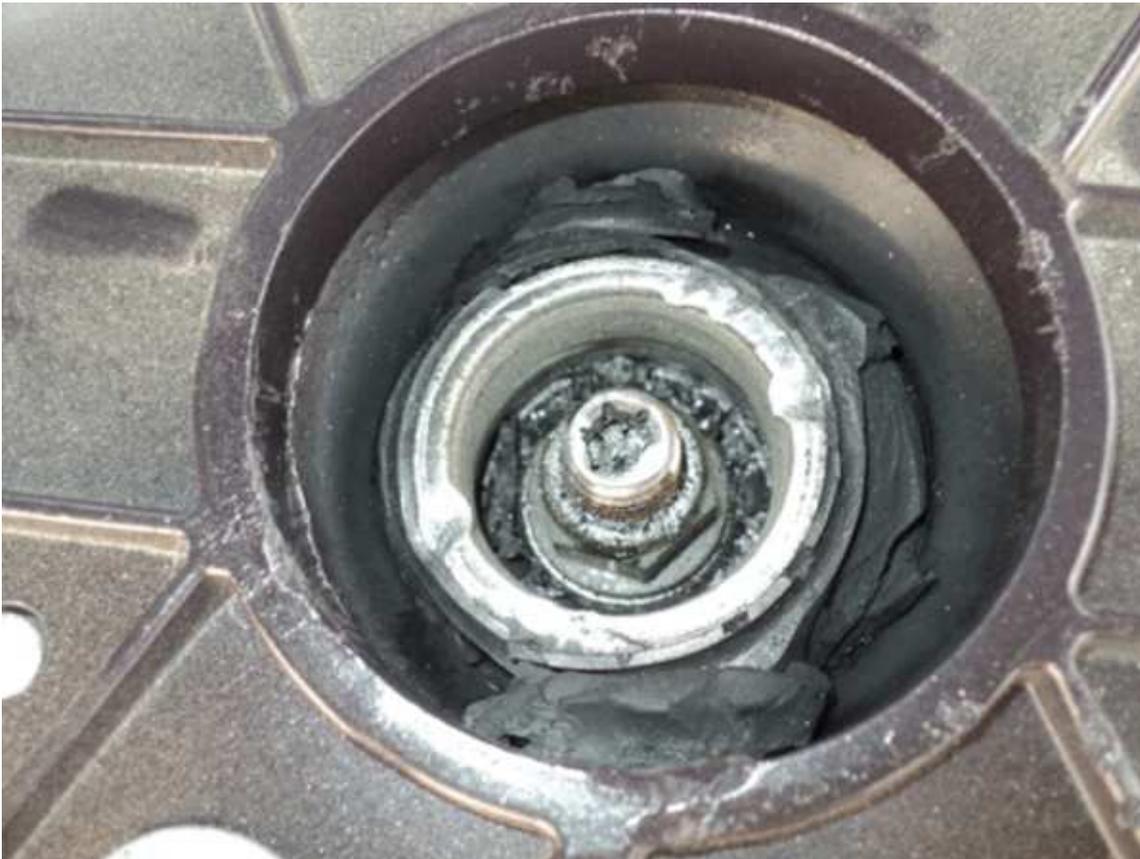
Some customers may comment on a popping noise when traveling over bumps.

This may be caused by the front strut mount being torn due to high underbody/underhood temps in addition to traveling over speed bumps.

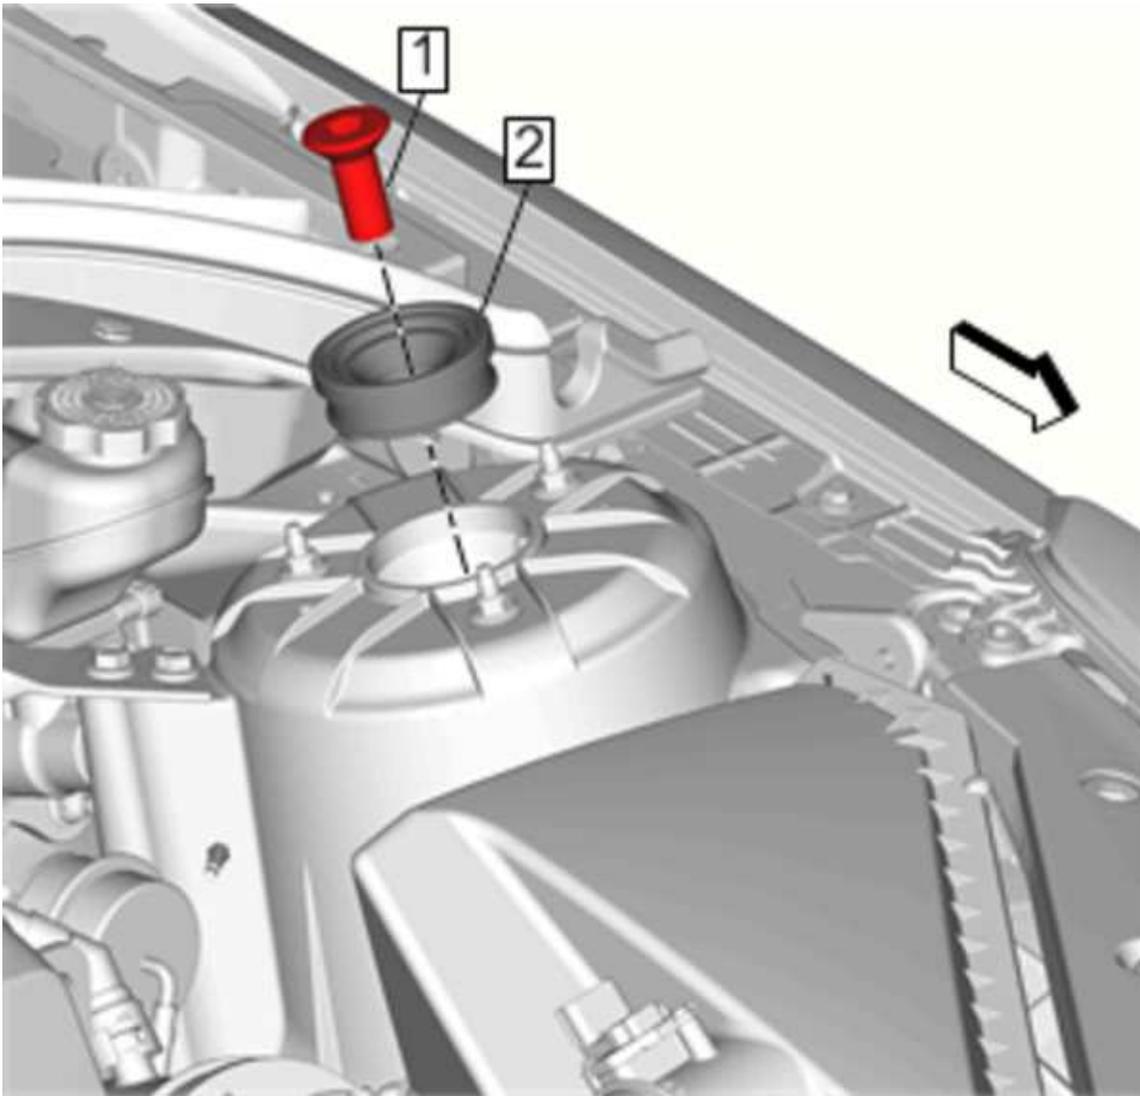
**Note:** The following parts (1) and (2) will not be present in vehicles that exhibit this condition. The following parts are the permanent corrective action to prevent the front strut mount from tearing.

3. In addition to replacing the strut mounts, install both the front suspension strut mount upper rebound cups (2).
4. Install both the front suspension strut mount rebound stops (1) and tighten to 25 N•m (18 lb ft).

**Important:** Tighten with the vehicle resting on the ground and ensure rebound stop is fully seated against the strut rod nut.
