Service Update

49560 Vehicle Shutdown No Restart

Reference Number: N162049560
GWM Number: 2049560

Make	Model	Model Year		RPO	Description
		From	To		
Cadillac	CT6	2016	2016

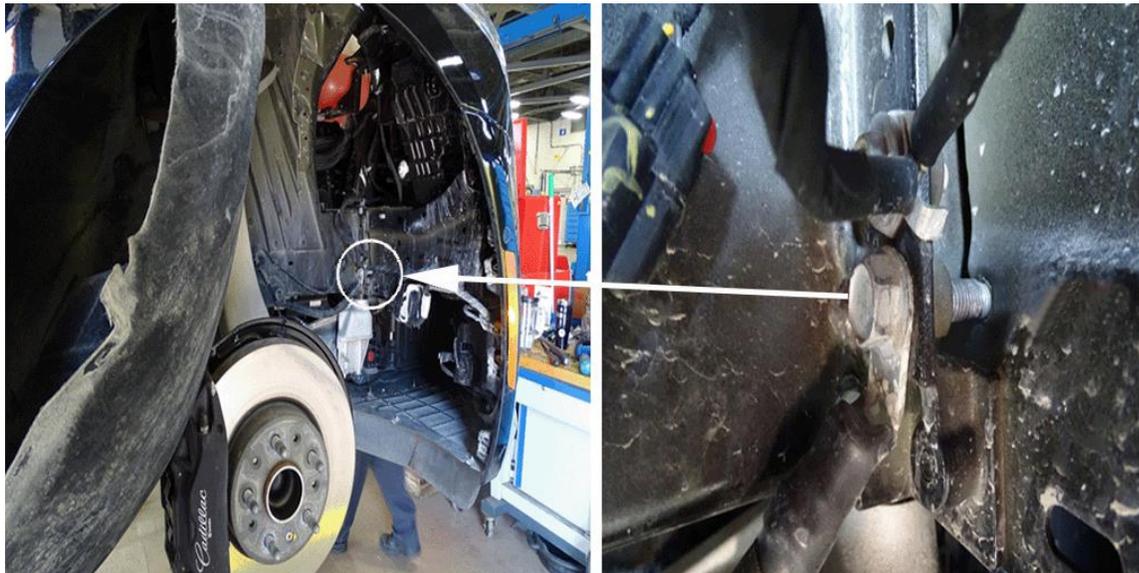
4580308

3. Locate G103.

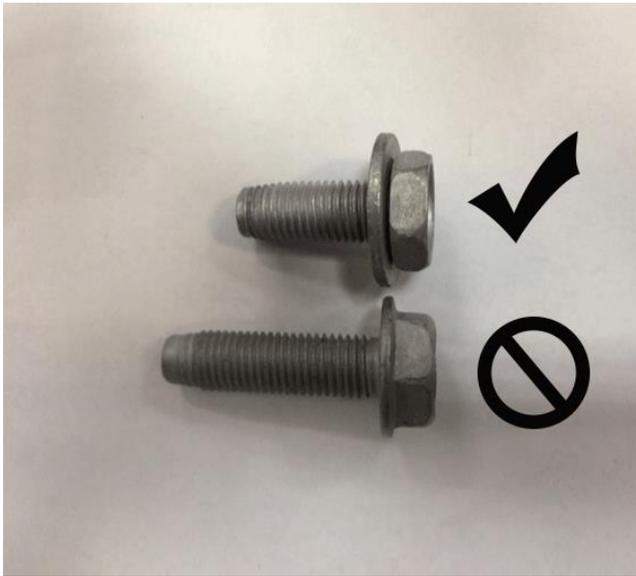
4. Inspect for the presence of a washer between the head of the bolt and the ground cable terminal.
 - If a washer is present, proceed to the next step.
 - If a washer is NOT present, replace the G103 bolt.

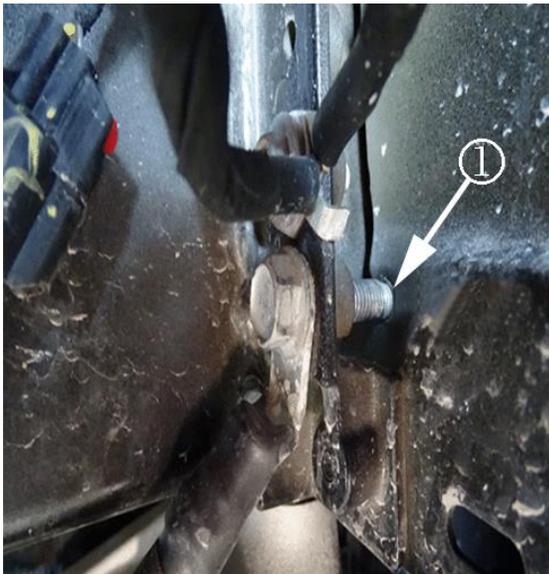
5. Inspect for the end of the bolt bottoming out against the frame (1).
 - If the bolt is NOT bottoming out against the frame, proceed to the next step.
 - If the bolt is bottoming out against the frame, replace the G103 bolt.
6. Attempt to slide a 0.5mm (0.020 in) feeler gauge between the washer and the ground cable terminal.
 - If the 0.5 mm (0.020 in) feeler gauge will NOT slide between the washer and ground cable terminal, proceed to the next step.
 - If the 0.5 mm (0.020 in) feeler gauge will slide between the washer and ground cable terminal, replace the G103 bolt.
7. Verify the G103 bolt is torqued to 22 Nm (17 lb ft).
8. Install the passenger front wheelhouse liner. Refer to *Front Wheelhouse Liner Replacement* in SI.
