# Special Coverage Adjustment

## 15682 Primary Tank Module Flange Fuel and Vapor Leaks

**Reference Number:** N150682 **Release Date:** September 2016  
**GWM Number:** 2015682 **Revision:** 02  
**Revision Description:** This bulletin is being revised to remove the TAC Part Restriction information from the Parts section. Please discard all previous copies of bulletin 15682.

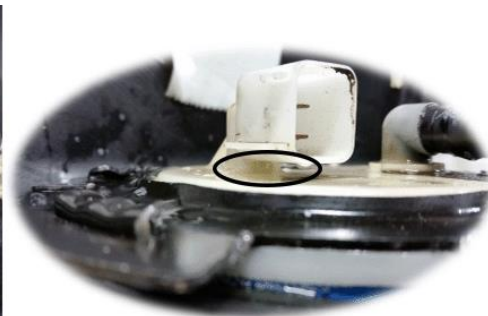
4567575

3. Inspect the area below the electrical connector (as shown above) for evidence of fuel leakage.
  - If there is evidence of fuel leakage, replace the fuel tank fuel pump module. Refer to Fuel Tank Fuel Pump Module Replacement - Left Side (LS3, LS7) or Fuel Tank Fuel Pump Module Replacement - Left Side in SI.
  - If there is NO evidence of fuel leakage, no further action is required. Inform the customer that any additional diagnosis and repairs are not covered under this special coverage.
4. If fuel was removed to perform the evaporative emissions system test in step 1, refuel the fuel tank to the previous level.
