Service Update

16017 Battery Cable Misaligned

Reference Number: N16204566

Make	Model	Model Year		RPO	Description
		From	To		
Chevrolet	Volt	2016	2017

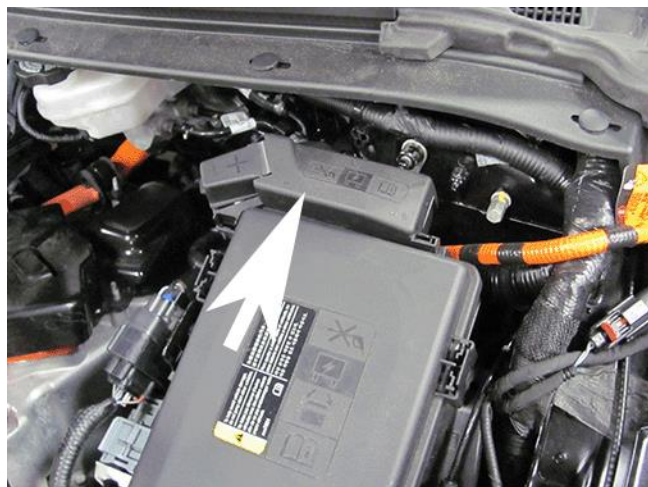
4584833

1. Raise the hood and locate the under hood fuse block. Remove the terminal cover.

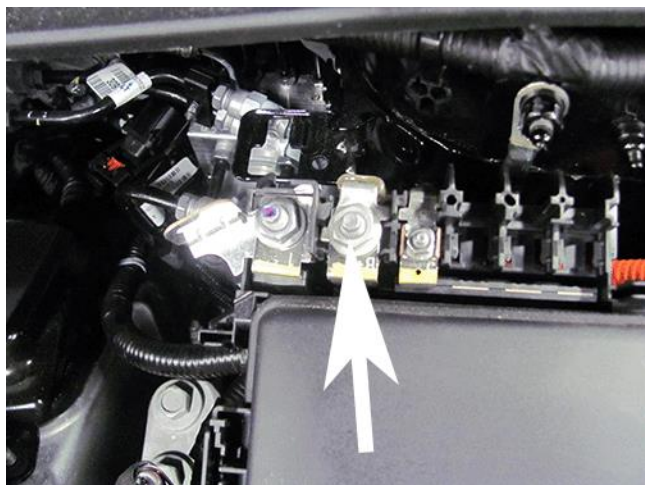
4584836

2. Locate the positive battery cable connection on the under hood fuse block (XB-50).

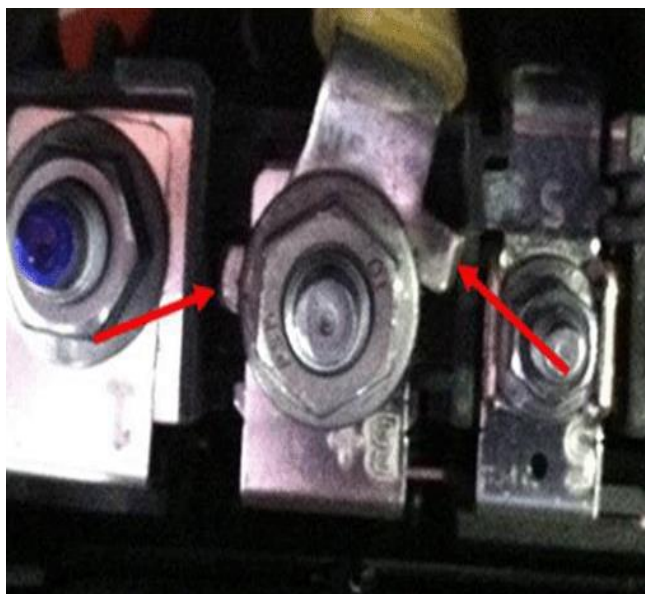
4533041

3. Verify the cable is not twisted, improperly seated or damaged. The photo above shows an improperly aligned battery cable.

NOTE: Ensure the tabs of the battery cable eyelet are not stuck on a plastic boss of the fuse block. This may cause the nut to be tight but the battery cable eyelet is not flushed or seated flat in the fuse box surface, which causes a poor or intermittent connection with the bus bar in the fuse box.
