Service Bulletin

PRELIMINARY INFORMATION

Brand:	Model:	Model Year:		VIN:		Engine:	Transmission:
		from	to	from	to		
Chevrolet	Colorado	2016	2016	SORP	G1354852	All	All
GMC	Canyon	2016	2016	SORP	G1354142	All	All

Involved Region or Country	North America
Additional RPO/s:	N/A
Condition	Front Of Seat Cover Comes Loose
Cause	Seat Frame Hem Flange Too Wide.

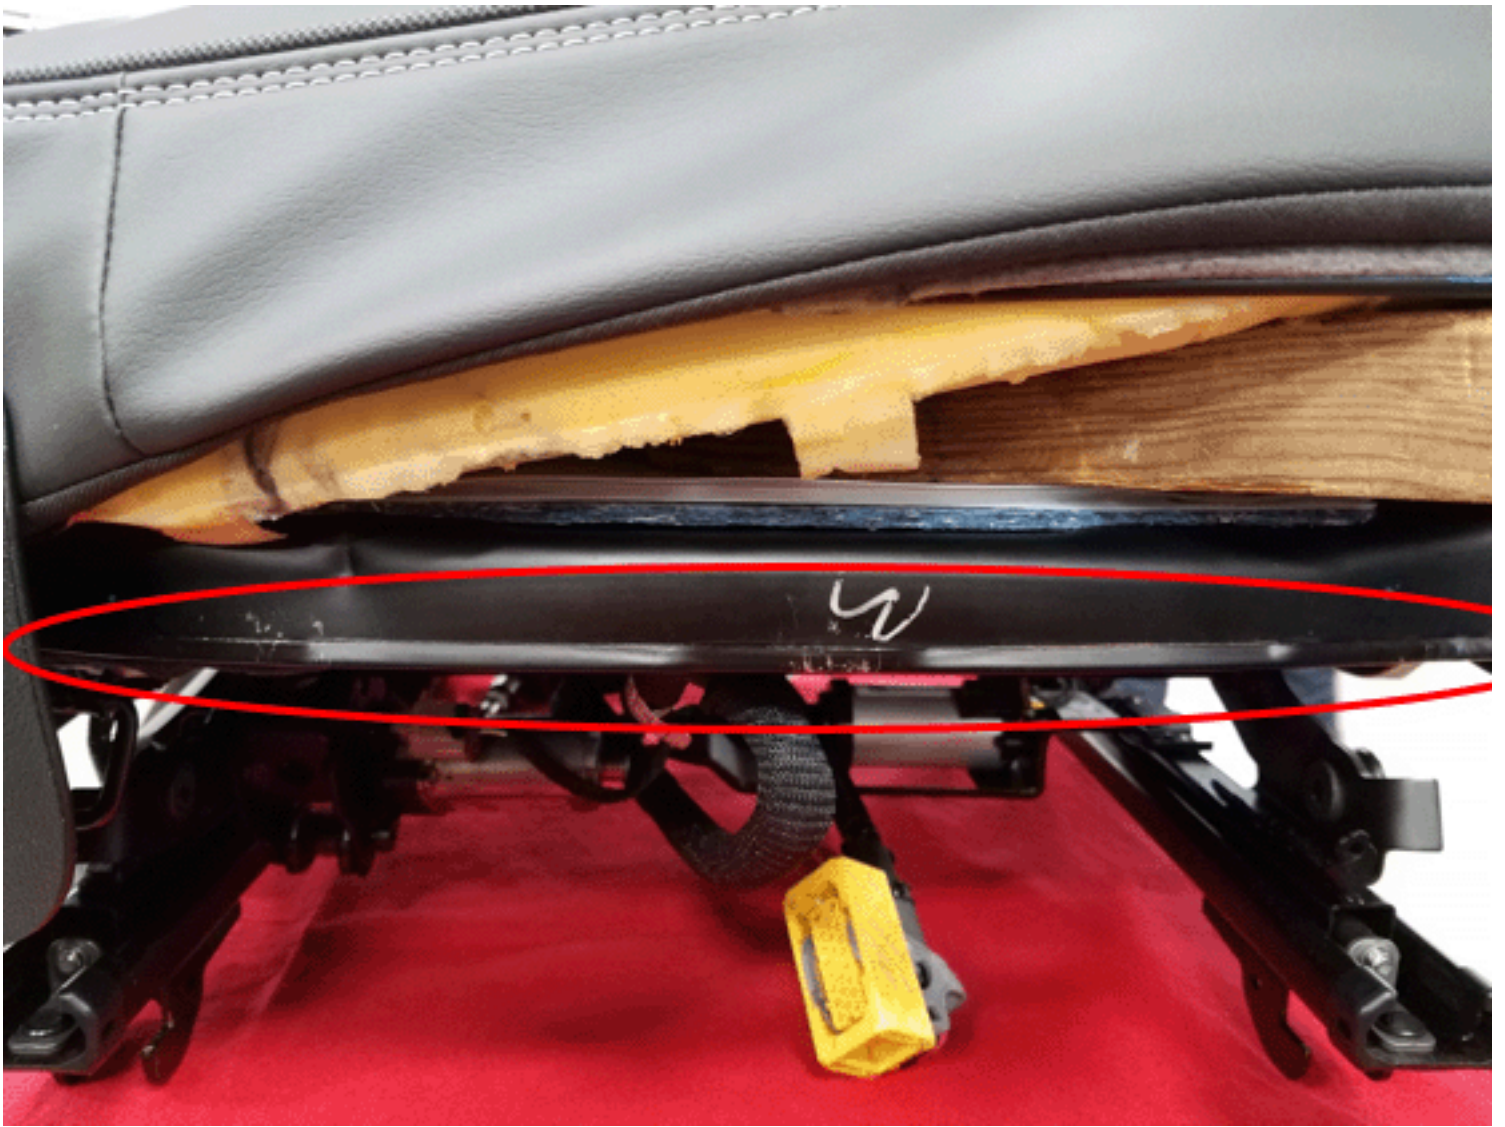
First remove the effected seat and place on a suitable surface with the front of the seat facing toward you. Raise the front of the seat cover, lift the cushion and support with a board or block.

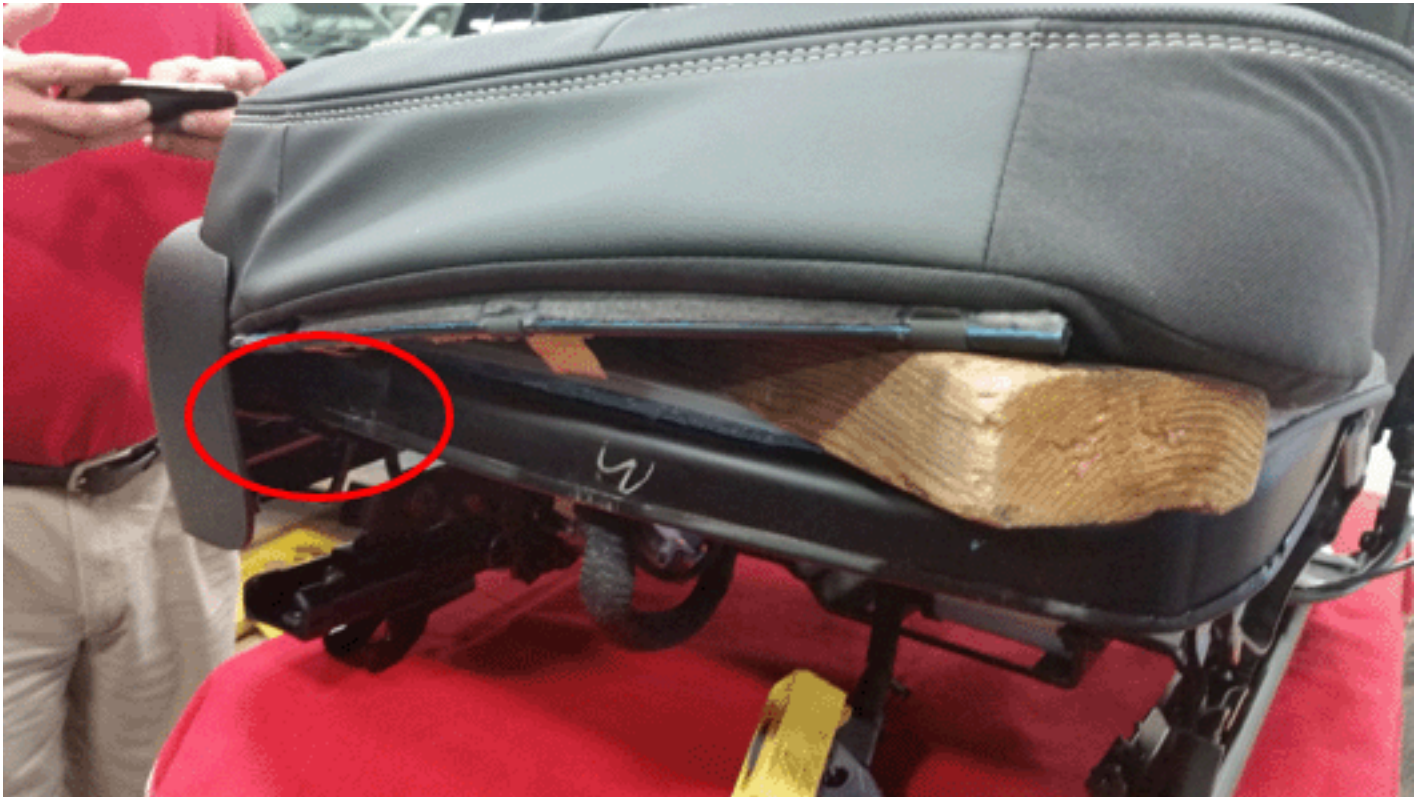
Entirely or partially remove the outboard trim cover and create clearance to the outer corner of the cushion pan hem surface (passenger seat shown).

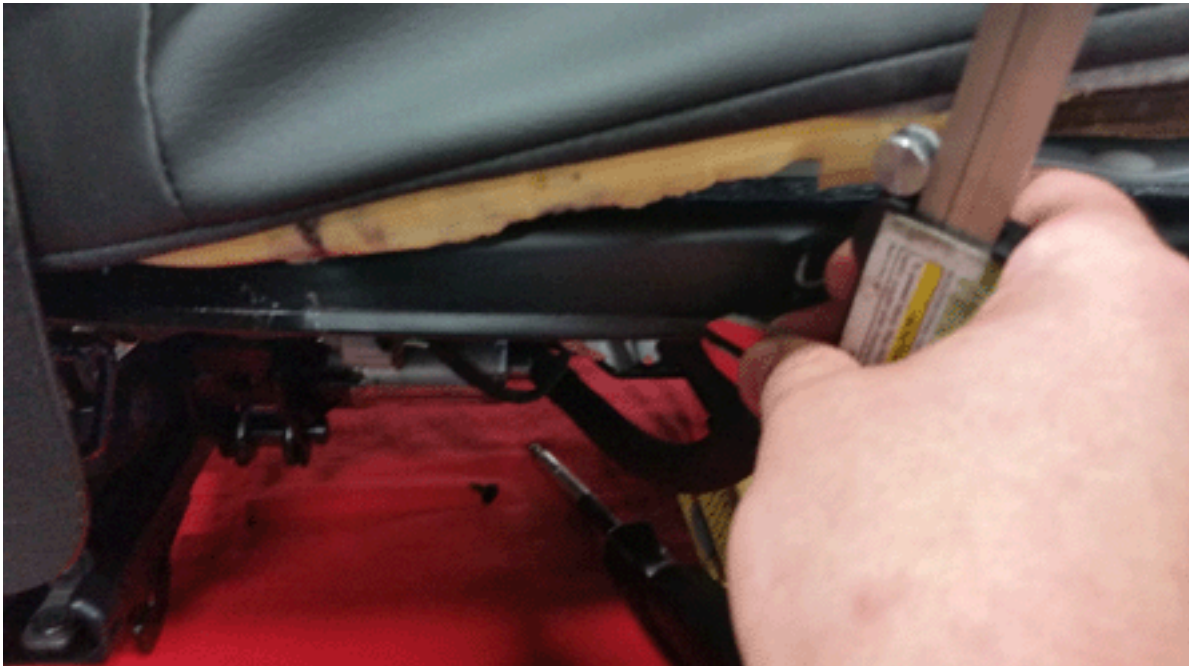
Using a pair of calipers set to 5 mm , mark the cushion pan flanges in the 3 areas where the profile is protruding away from the rest of the cushion pan (hem fold is open in these locations, not tight to the structure)

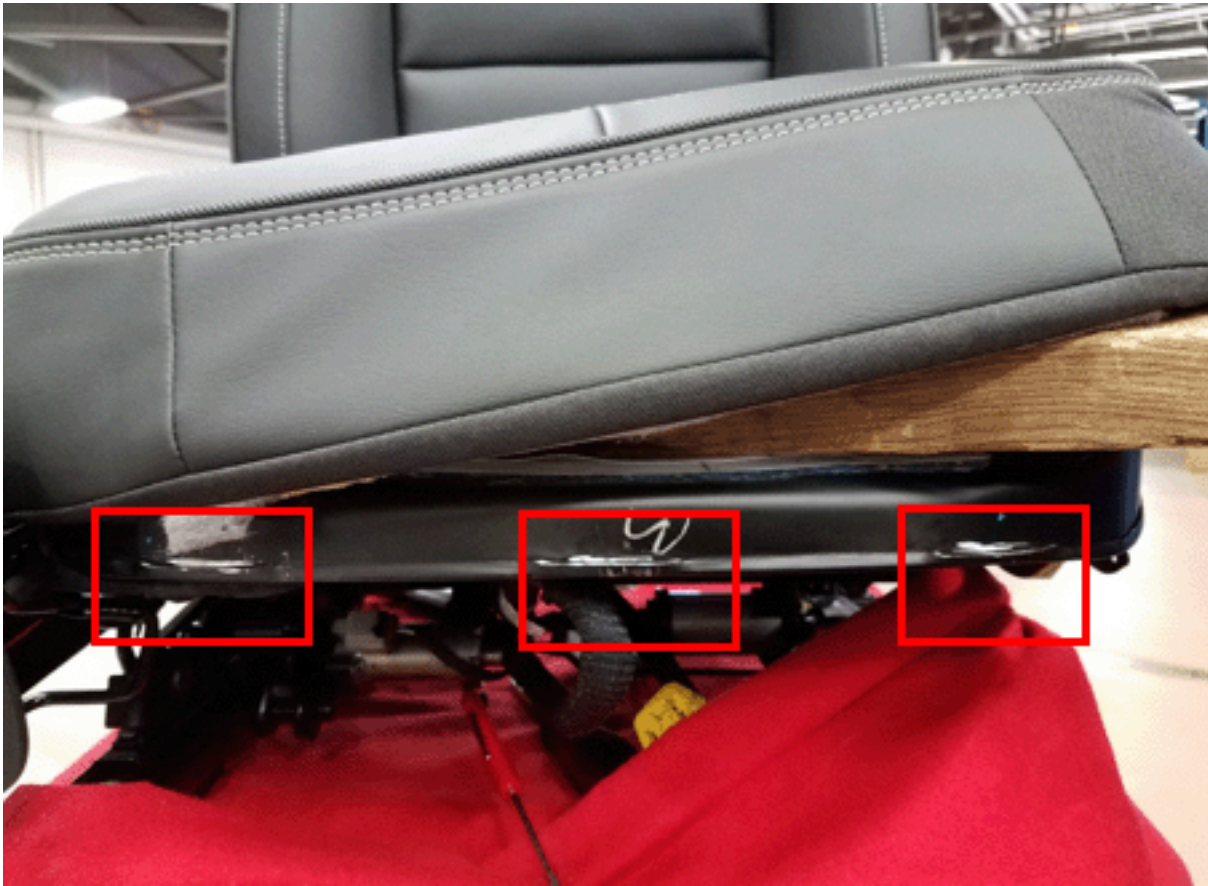
Be sure to mark the entire edge of the hem where it stands out from the rest of the pan.

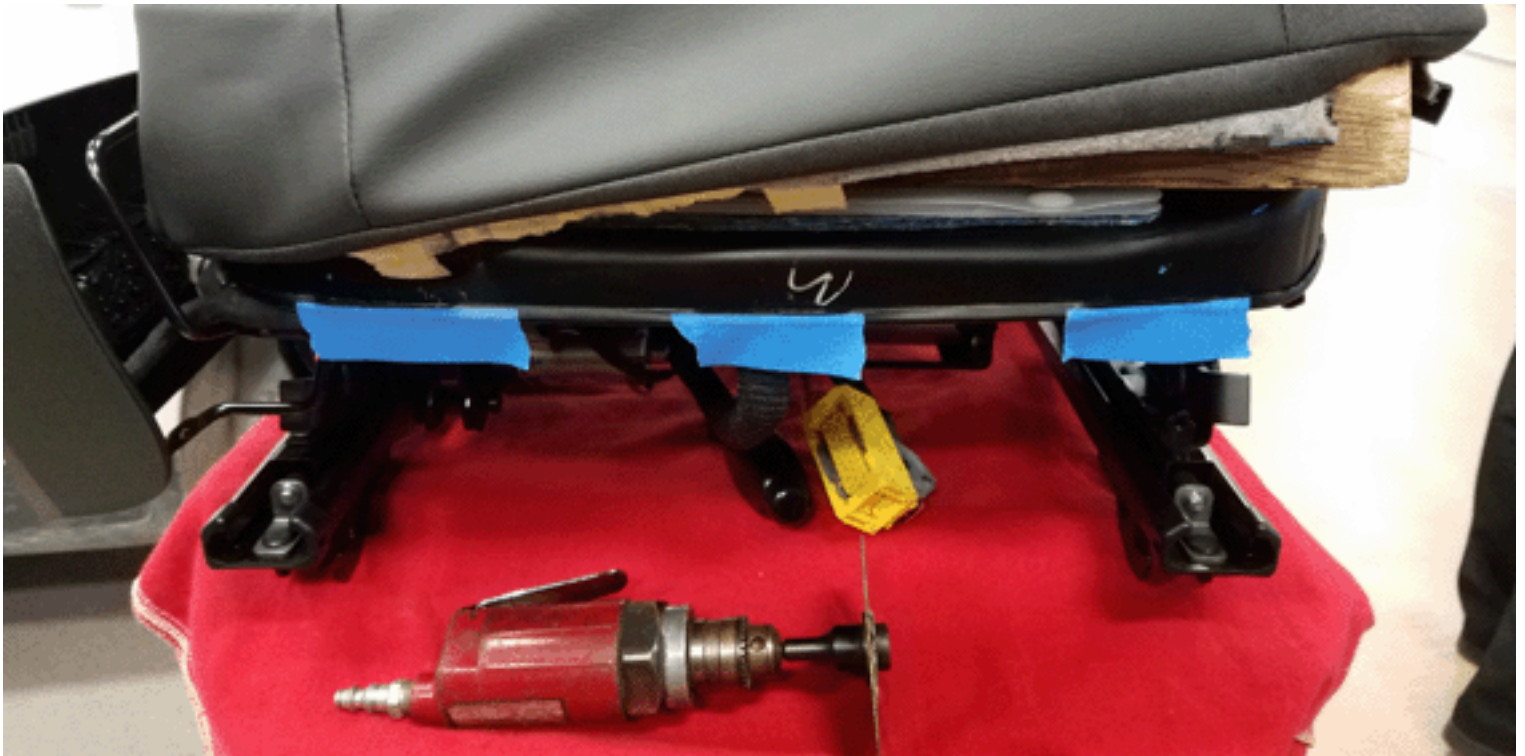
As an extra visual guide, carefully add tape to the flanges, aligned with the scored marks made in the previous step. Add a fender cover, blanket or other protective cover to keep material and debris out of the seat track adjusters.

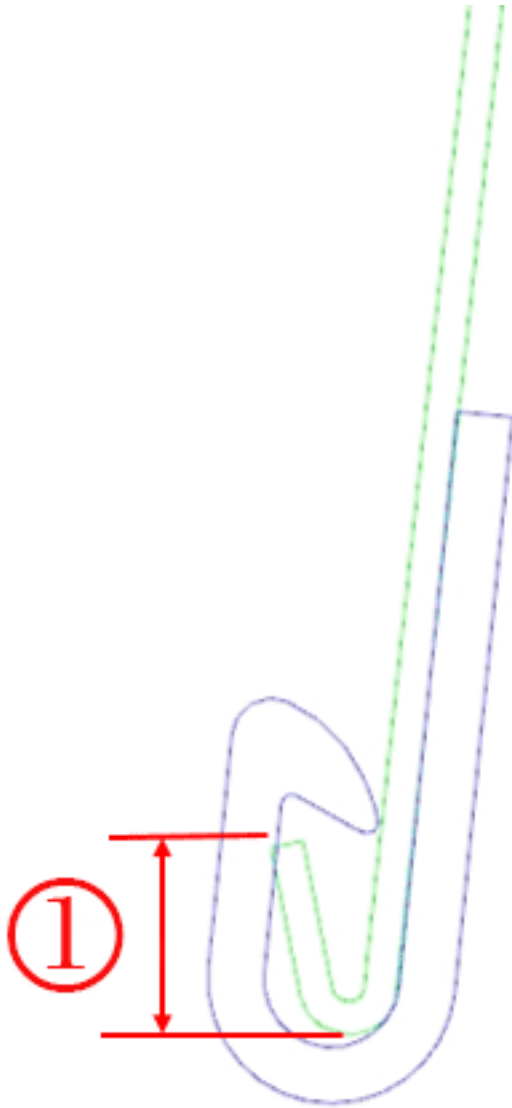
Again using the calipers check to make sure the flange in the areas cut is between 4-5.5 mm, if not, continue removing material until this condition is met. Use a deburring tool, pick or small screwdriver to ensure there's no debris, burrs, or other material inside the open areas of the cushion flange that have been cut. Depending on the cut, a tool may be needed adjust the hem back out so that the barb on the plastic J retainer can engage.(1)

Use a die grinder and cutting wheel to remove material, reducing the hem height to the 5 mm as previously measured. It's important to remove the material across the entire length of the 3 portions of the flange not folded tightly upon itself.
