Service Bulletin

Subject: Engine May Shut Off After Wide Open throttle Maneuvers SES Lamp Setting P0121 P02101 And P2119

Brand:	Model:	Model Year:		VIN:		Engine:	Transmission:
		from	to	from	to		
Cadillac	CTS-V	2016	2017	SOP	END	6.2 LT4	N/A

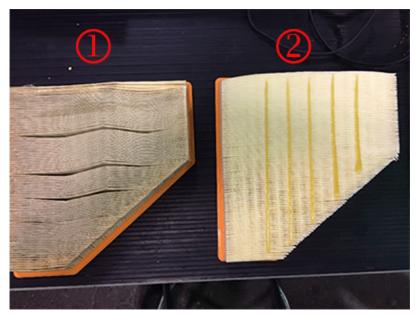
Inspect the air filter for damage from being collapsed shut as shown below by filter #1.

- **1.** This is the incorrect air filter with no glue lines
- 2. This is the correct air filter with glue lines

Replace the air filter if it is incorrect

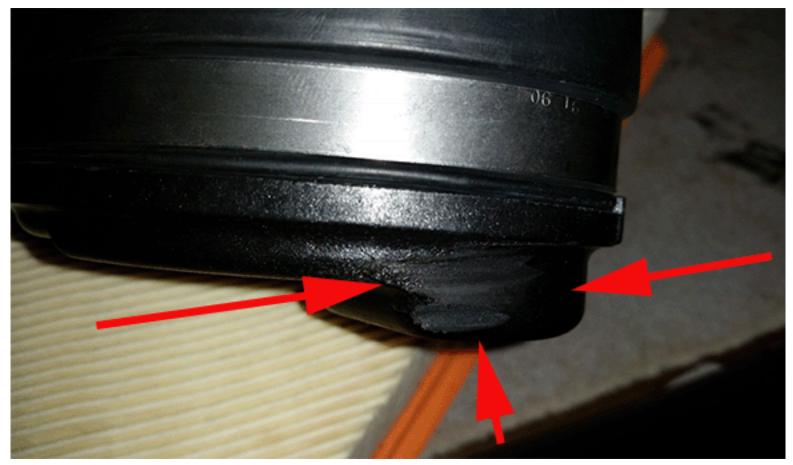
When the air duct collapses it may come in contact with the supercharger idler pulley Do not replace ECM, Throttle Body.

If this is encountered the air duct should be replaced with the air filter.
