Bulletin No.: PIC5521B

Subject: Front Seat Cage Nut Spins - Unable To Remove Bolt

Models: 2010 - 2015 Chevrolet Camaro

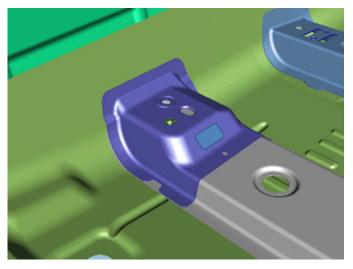
A technician may experience difficulty removing one of the front seats. He may comment that one of the bolts is spinning, but it will not come out of the floor pan. This could be caused by a cage nut that broke loose from the weld in the floor pan during removal of the bolt.

- 1. To remove the seat you will need to cut or drill the head of the bolt off.
- 2. Remove the seat following published procedures and reposition the carpet as needed to allow the remainder of the steps to be completed
- 3. Cut a square hole 45 mm (W) X 35 mm (H) in the Seat Anchor Bracket containing the loose cage nut, as illustrated below.

- **4.** Remove the cage nut from the Seat Anchor Bracket and, using a vise and pliers, remove the remainder of the bolt from the nut. Clean the threads of the nut as necessary.
- 5. Drill two 5mm holes next to the bolt hole in the Seat Anchor Bracket. These holes should be 180 degrees opposite of each other. This will allow the nut to be tack welded back in place.

Important: It is critical that the nut be centered in the hole. If it is off to either side of the car, this will cause the seat track to bind.

- 6. Holding the nut in the proper location, place two tack welds in the previously drilled holes to retain the nut to the bracket.
- 7. Clean the welds to allow proper fit of the seat adjuster to the floor pan.
- **8.** Apply the anti-corrosion materials to the repair area and paint as necessary.
