Bulletin No.: PIC6127E

Service Bulletin

Subject: (Volt) High Voltage Drive Motor Battery TAC Restriction and Exchange Program

Models: 2016-2017 Chevrolet Volt

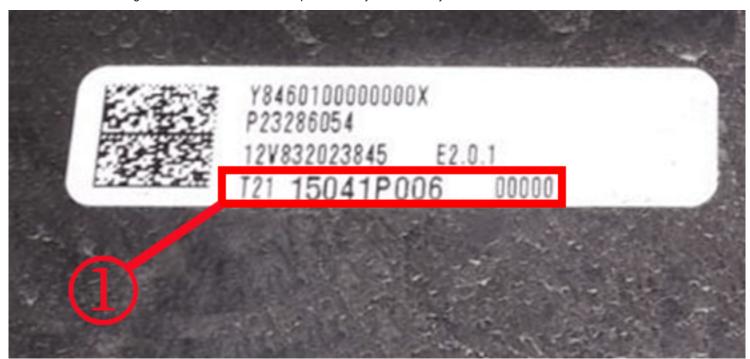
- 6.2 The battery has a battery identification tag that is located on the right side of the battery. Locate the tag and record the 16 digit battery identification number (BIN). The BIN is the bottom most number on the label and it starts with a "T" indicator (See Photo Below). If the battery is not out of the vehicle yet, you can find the BIN by installing the MDI and using GDS 2. Access the Battery Energy Control Module and look under theidentification information section and the sixteen digit number will be listed under the parameter: Hybrid/EV Battery Pack Identification Number
