Service Bulletin

PRELIMINARY INFORMATION

Subject: Rattle Noise From Second Row Seat

Models: 2015-2017 Cadillac Escalade Models
2015-2017 Chevrolet Suburban, Tahoe
2015-2017 GMC Yukon Models

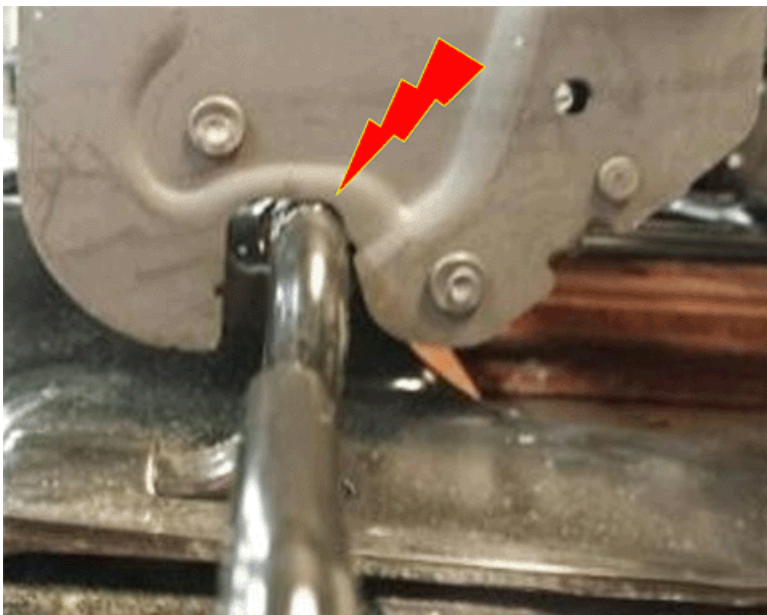
Condition 1: Striker not aligned properly fore/aft in latch opening, see picture below

This could cause a rattle or the striker to drag on the side of the latch opening not allowing the seat to flip forward or latch down easily.

Condition 1 Repair: Striker not aligned properly fore/aft in latch opening

To repair this condition, rework/adjust the striker in the direction to center it in the latch opening. An adjustable wide mouth metal working tool may be used to carefully rework/adjust the striker just enough to center in the latch opening, as shown below.

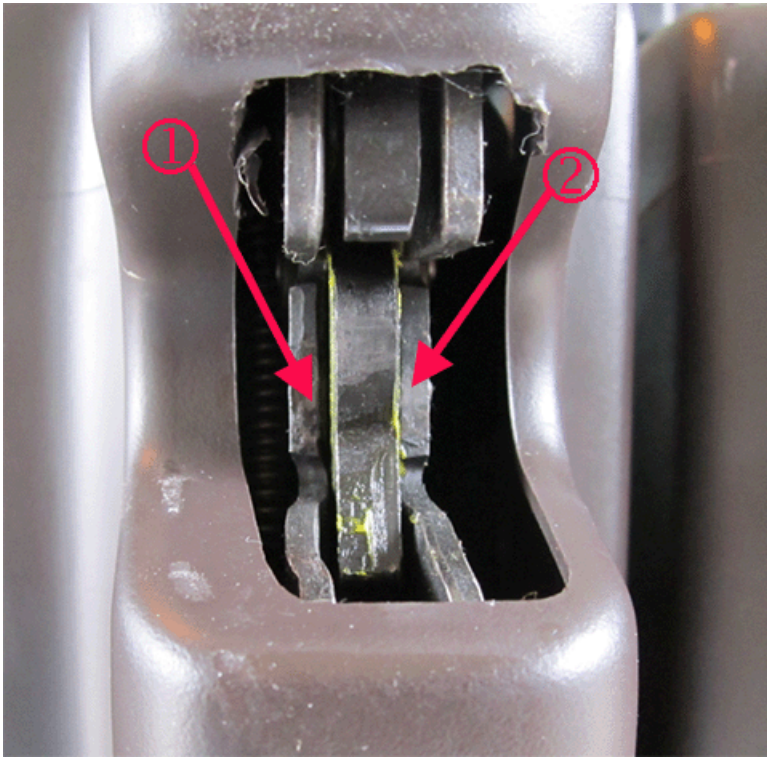
Condition 2: A seat bottom latch (inboard and/or outboard) may have an unequal latch opening side-to-side for the striker to seat into, see picture below. Opening (1) may protrude down farther than opening (2), which can cause a rattle, and which may make it difficult to secure and/or release latches.

With the seat latched down, if the striker to latch interface is inspected on both sides of a latch, there will be a gap on one side of the latch and no gap on the other side of the same latch.

Condition 2 Repair: A seat bottom latch (inboard and/or outboard) may have an unequal latch opening side-to-side for the striker to seat into. This procedure will form the protruding latch opening to the striker, which will allow the two openings (1, 2) to be equal/parallel to each other so the striker contacts both openings.

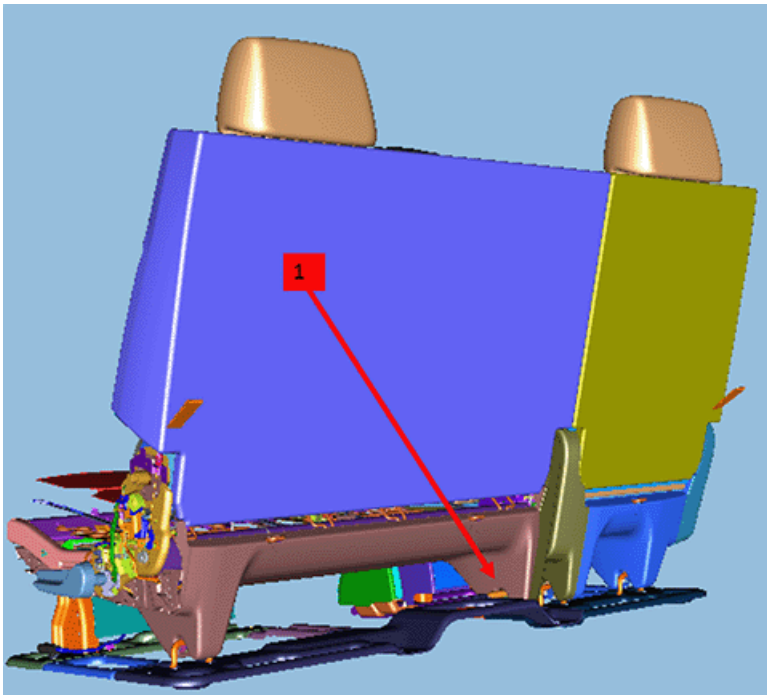
Condition 3: 60/40 Split Bench Seat: 60-percent long side bench, inboard latch (1) may not be properly aligned fore/aft in striker opening. Could cause a rattle and/or the striker to drag on the side of the latch opening not allowing the seat to flip forward or latch down easily.

Condition 3 Repair: 60/40 Split Bench Seat: 60-percent seat, inboard latch (1) may not be properly aligned fore/aft in striker opening.

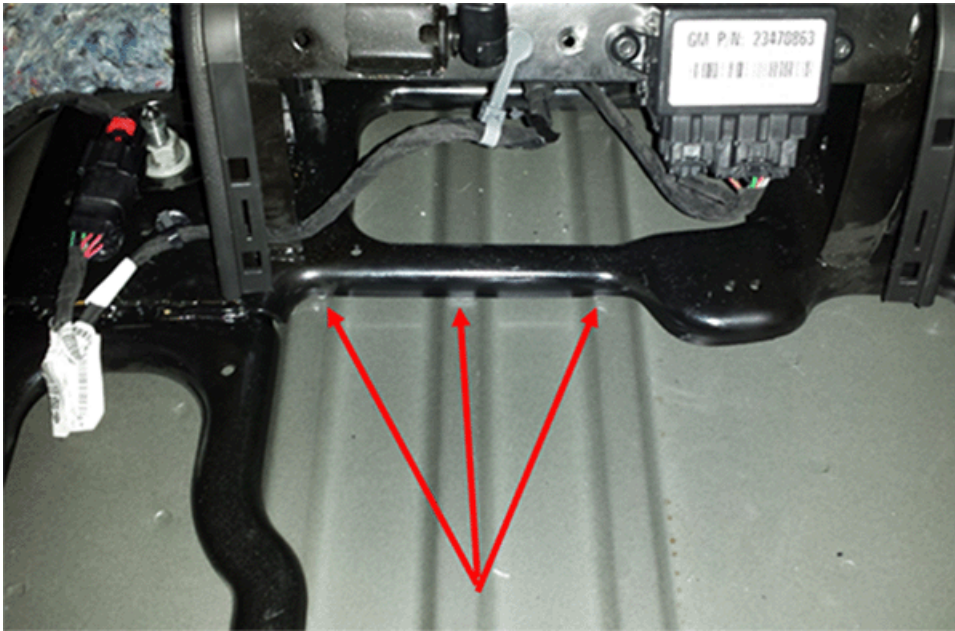
Condition 4: Seat base plate contacting/rattling against ribs of floor pan.

Condition 4 Repair: Seat base plate contacting/rattling against ribs of floor pan.

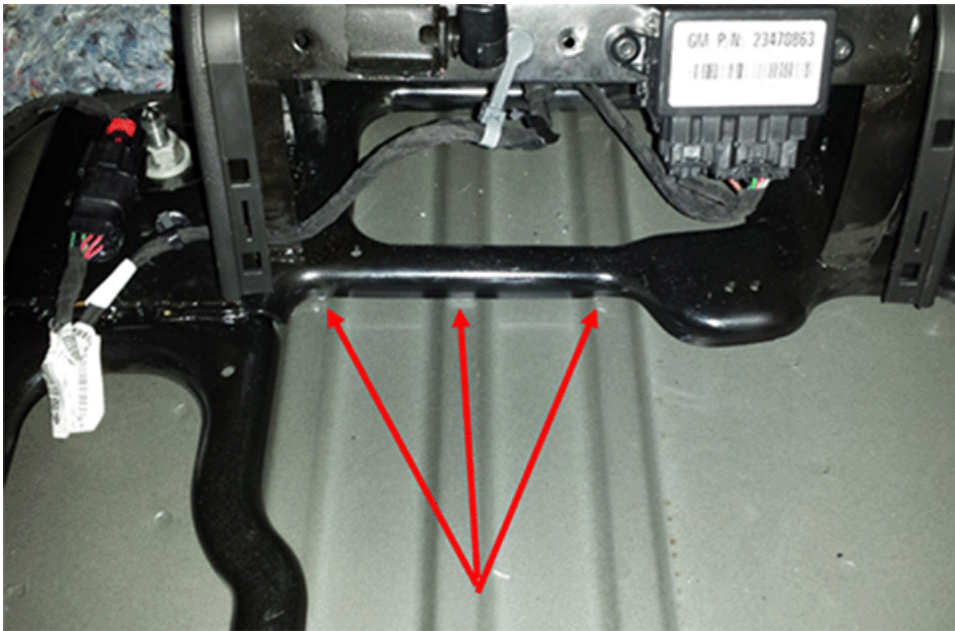
4.2 Inspect the seat base plate for contacting the ribs of the floor pan, as shown below. If contact is present paint damage may be visible at the area of contact.

4.3 Apply Mylar tape to the floor pan to provide relief for the rattle condition, then reevaluate.
