Service Bulletin

PRELIMINARY INFORMATION

Subject: Rough Idle In Drive

Models: 2015-2017 Cadillac Escalade Models
2014 Chevrolet Silverado 1500
2015-2017 Chevrolet Silverado 1500, Suburban, Tahoe
2014 GMC Sierra 1500
2015-2017 GMC Sierra 1500, Yukon Models
With engines 4.3L, 5.3L, 6.2L RPO L83, L86, LV1, LV3

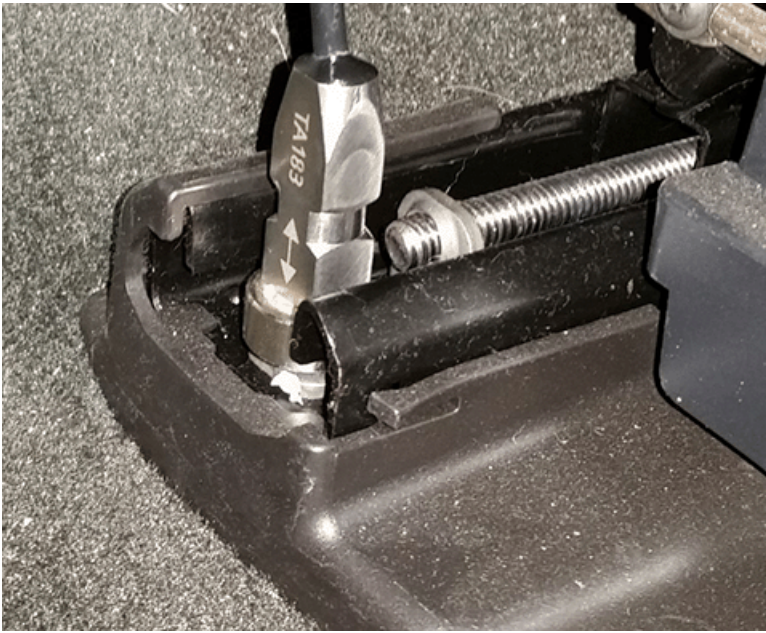
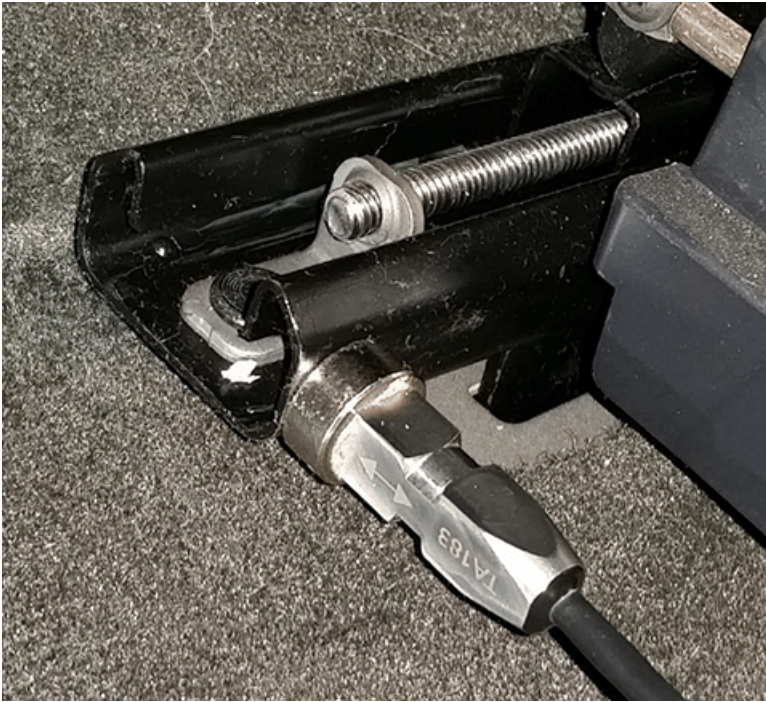
Note: If using a single-axis pico sensor, mount and test both vertically and horizontally – E1.5 rough idle vibration will usually be horizontal / lateral at the seat track.

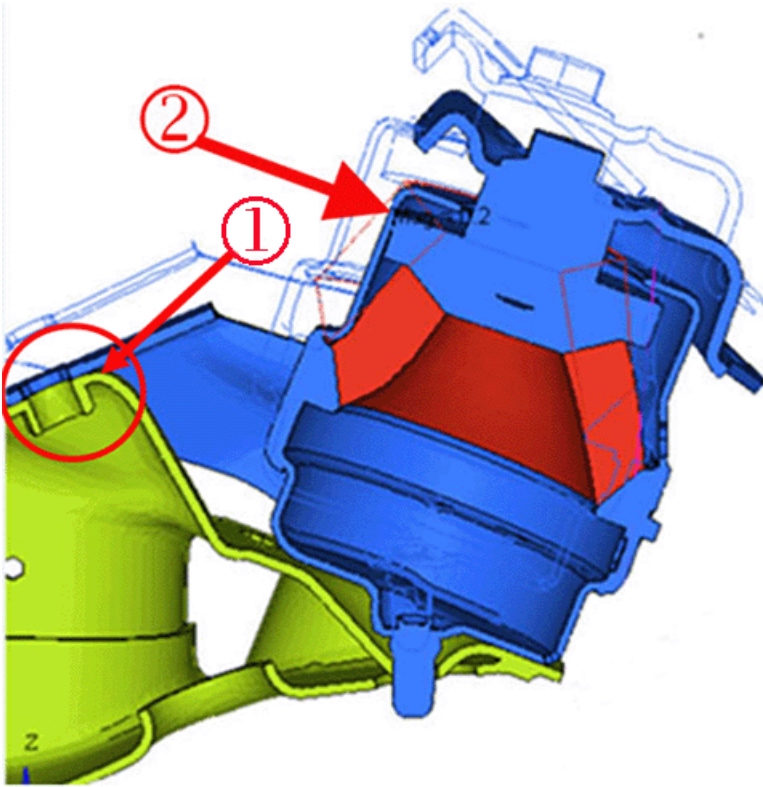
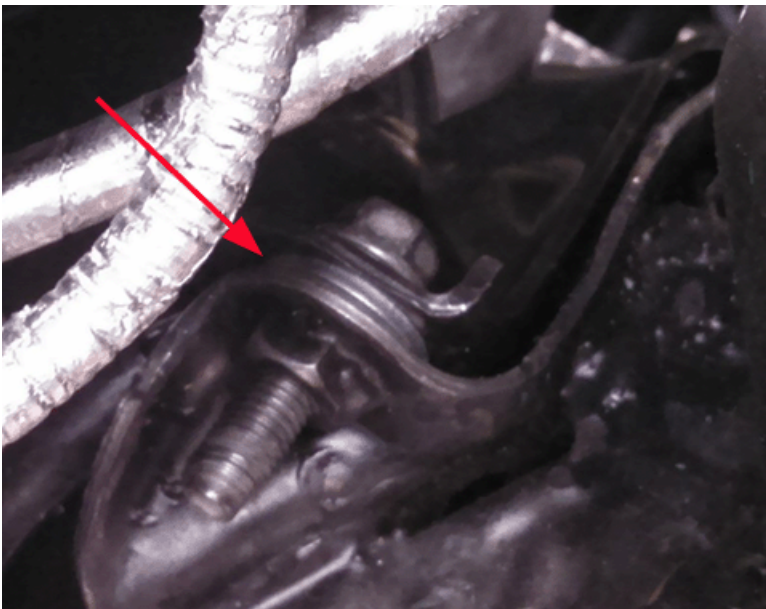
Spacer Washer at Frame Bolt Location Example

Note: Often the idle vibration caused by ground-out within an engine mount (2) may be able to be turned off/on with a single bolt location – shimming that bolt location may greatly reduce the vibration. In some cases, a combination of bolt location shimming may be needed.

Note: For spacer washers mild steel is recommended, no stainless; it may be necessary for some locations to use a small amount of adhesive such as 'dum-dum' to hold spacer in place.

- 1.5. If idle vibration could Not be turned off/on – repeat process with middle bolt.
 - 1.6. If the idle vibration Could be turned off/on with one bolt, add a spacer washer, approximately 2.5 mm thick (1) when the engine mount and frame attachment at that bolt location.
