HYUNDAI NEW THINKING. NEW POSSIBILITIES. Technical Service Bulletin	GROUP CAMPAIGN	NUMBER 16-01-061
	DATE NOVEMBER 2016	MODEL(S) ELANTRA (ADa)
SUBJECT: OVERHEAD CONSOLE LAMP BULB SOCKET REPLACEMENT (SERVICE CAMPAIGN T1F)

Description: On certain 2017 Elantras, the overhead console lamp intermittently does not turn ON.

Applicable Vehicles: Certain 2017 Elantra (ADa)

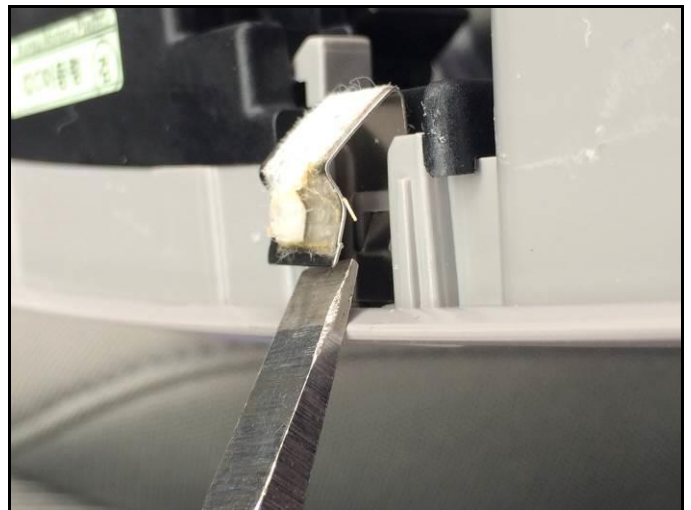
5. Inspect the overhead console lamp assembly side clips to ensure they are not deformed.

If the side clips are deformed, rattles can occur with the bracket or a gap between the headliner and the overhead console lamp assembly.

If the side clips are deformed, use a flathead screwdriver to bend the clips into the correct position.

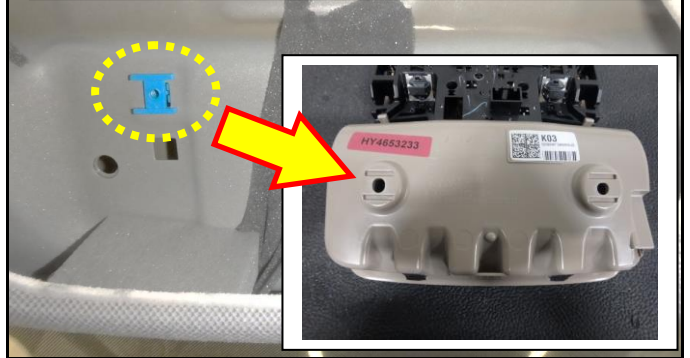
- 6a. If the two screws slip during the tightening process, ensure the overhead console assembly is firmly pressed against the roof and the holes are aligned.

By pressing the overhead console assembly against the roof, it will hold the clip in place through the two ridges.

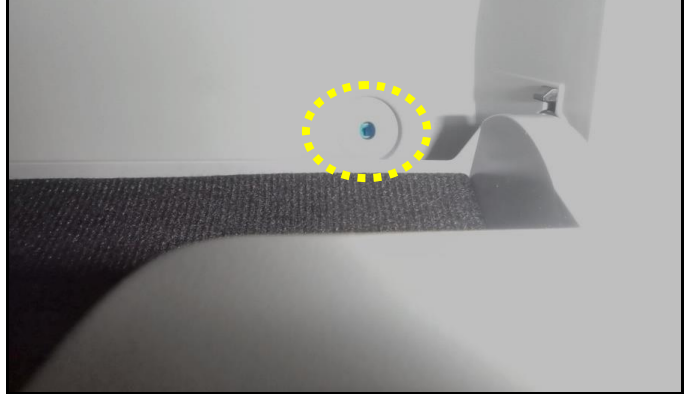
Clip hole is aligned with the overhead console assembly.
