GROUP	NUMBER
AUTOMATIC TRANSMISSION	16-AT-006-1
DATE	MODEL
NOVEMBER 2016	Accent (RB), Azera (TG/HG), Elantra (UD/MD/GD/JK/AD), Santa Fe (CM/AN/NC), Sonata (YF/YF HEV/LF/LF HEV/PHEV), Tucson (LM/TL), Veloster Turbo (FS)

AUTOMATIC TRANSAXLE SHIFT LEVER DIAGNOSIS (6-SPEED)

This TSB supersedes 16-AT-006 to update the Service Procedure (Step 14).

Description: The shift lever on some 6-speed vehicles may intermittently not shift out of Park. This bulletin provides the diagnostic procedures to correct this condition.

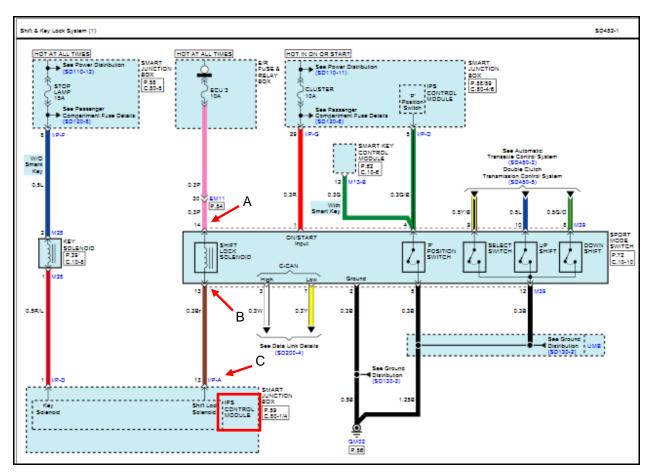
- 13. Refer to the shop manual and locate the BCM or IPM. Disconnect the connector to the BCM/IPM that provides ground for the shift lock solenoid (C).
 - Use a small pin to probe the harness side of the connector and connect to ground. If the shift lever:
 - Releases from Park, the solenoid and shift lever are functioning properly.
 - Does not release from Park: Inspect the harness between the shift lock solenoid (B) and BCM/IPM (C) for an open/short circuit. If OK, go to Step 14.

14. **For HG and FS**: Exchange the IPM Unit (IPS Control Module) from a known good vehicle and reconnect the connector. If the shift lever moves out of Park, replace with a new IPM.
