SERVICE BULLETIN

Classification: EL15-002d	Reference: NTB15-009d	Date: December 20, 2016
------------------------------	--------------------------	----------------------------

NAVIGATION SYMPTOMS WHEN SD CARD IS MISSING OR WRONG CARD INSTALLED

APPLIED VEHICLES: 2015-2017 Murano (Z52)
2016 Murano Hybrid (Z52)
2016-2017 LEAF (ZE0)
2016-2017 Maxima (A36)
2017 GT-R (R35)

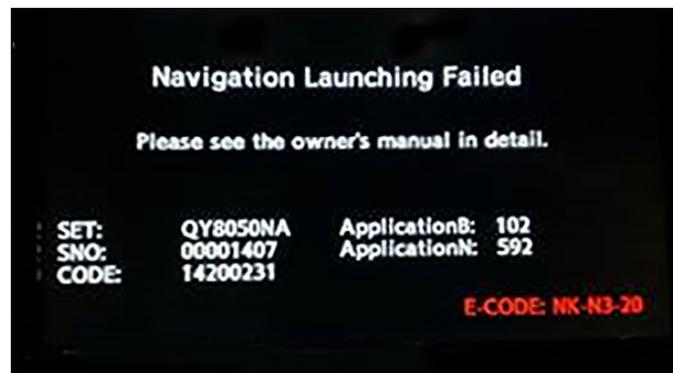
- A “**Navigation Launching Failed**” screen will be shown (Figure 1). For example, this will occur if a “596” SD Map Card is installed in a version “592” vehicle (ApplicationN, Figure 1).

- **Mixed up with other SD Map Cards**
Continue to insert individual SD Map Cards until one can be found that the error message in Figure 1 is not displayed.
NOTE: There are no visual differences printed on the outside of individual SD Map Cards to distinguish between the different versions.
- **Lost**
Order a new SD Map Card from Nissan. This is not covered under warranty.
