SERVICE BULLETIN

Classification: EC16-011a	Reference: NTB16-030a	Date: December 1, 2016
------------------------------	--------------------------	---------------------------

2013-2016 ALTIMA WITH QR25DE ENGINE; MIL ON WITH DTC P0101

APPLIED VEHICLE: 2013-2016 Altima (L33)

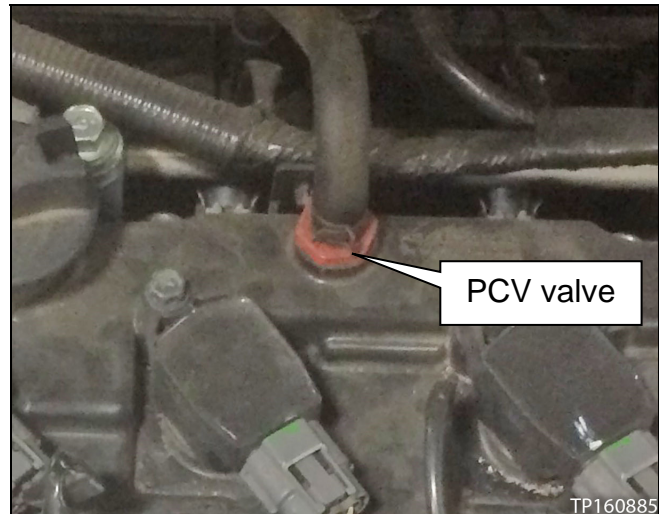
Figure A

2. If the PCV valve is **orange** in color, replace it.

NOTE: The new PCV valve is **black** in color.

3. If the vehicle's PCV valve is already **black** in color, do not replace it.

- See **PARTS INFORMATION**.
- Refer to the Electronic Service Manual (ESM), section **EC-Engine Control System**, for PCV valve replacement information.

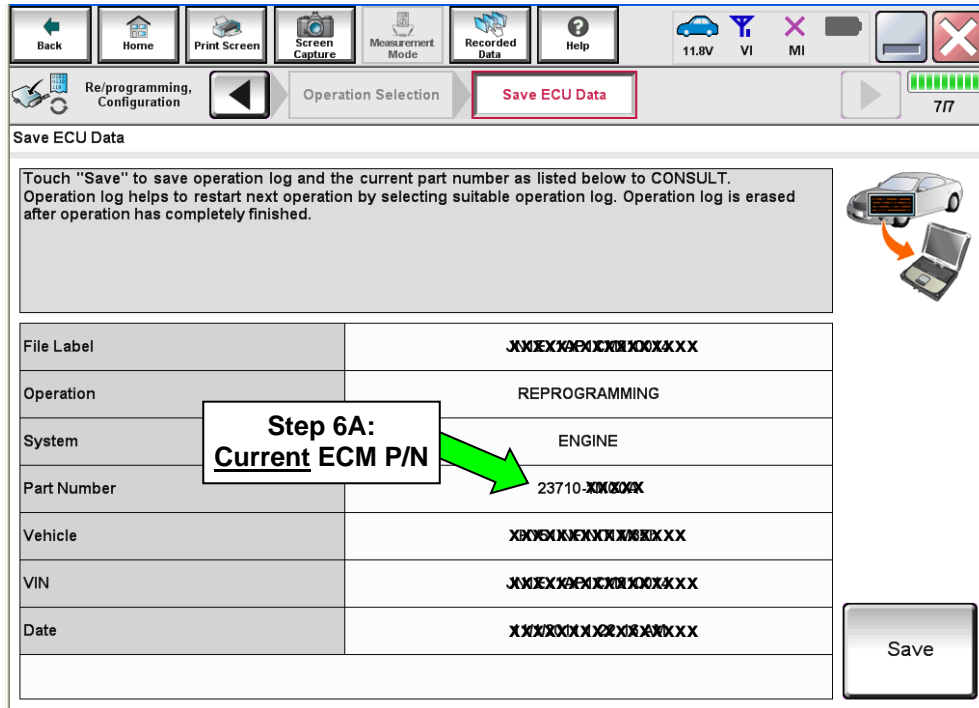
Figure 2

6. When you get to the screen shown in Figure 2, confirm this bulletin applies as follows.

A. Find the ECM **Part Number** and write it on the repair order.

B. Compare the P/N you wrote down to the numbers in the **Current ECM Part Number** column in **Table A** on the next page.

- If there is a match, this bulletin applies. Continue with the reprogramming procedure.
- If there is not a match, the ECM does not need to be reprogrammed. Close C-III plus and refer to ASIST for further diagnostic information as needed.

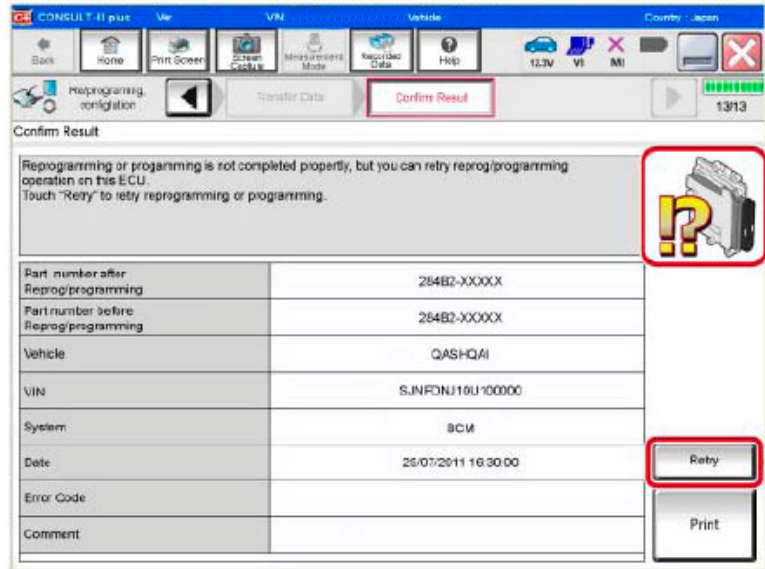
Figure 5

If reprogramming does not complete and the “!?” icon displays as shown in Figure 5:

- Check battery voltage (12.0 - 15.5 V).
- Ignition is ON, engine OFF.
- External Bluetooth® devices are OFF.
- All electrical loads are OFF.
- **Select retry and follow the on screen instructions.**
- “Retry” may not go through on first attempt and can be selected more than once.

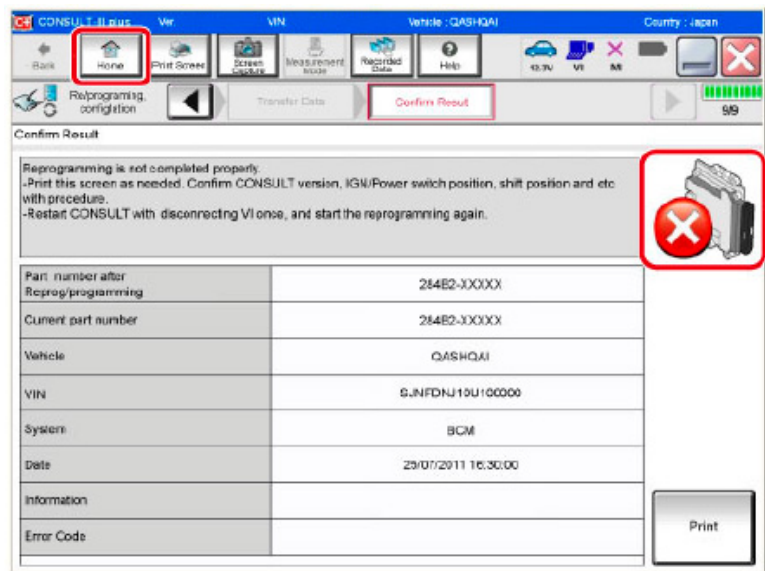
Figure 6

If reprogramming does not complete and the “X” icon displays as shown in Figure 6:

- Check battery voltage (12.0 - 15.5 V).
- CONSULT A/C adapter is plugged in.
- Ignition is ON, engine OFF.
- Transmission is in Park.
- All C-III plus / VI cables are securely connected.
- All C-III plus updates are installed.
- **Select Home, and restart the reprogram procedure from the beginning.**
