SERVICE BULLETIN

| Classification: EL13-050a | Reference: NTB13-107a | Date: November 29, 2016 |

INTELLIGENT KEY NOT DETECTED / ENGINE WILL NOT START

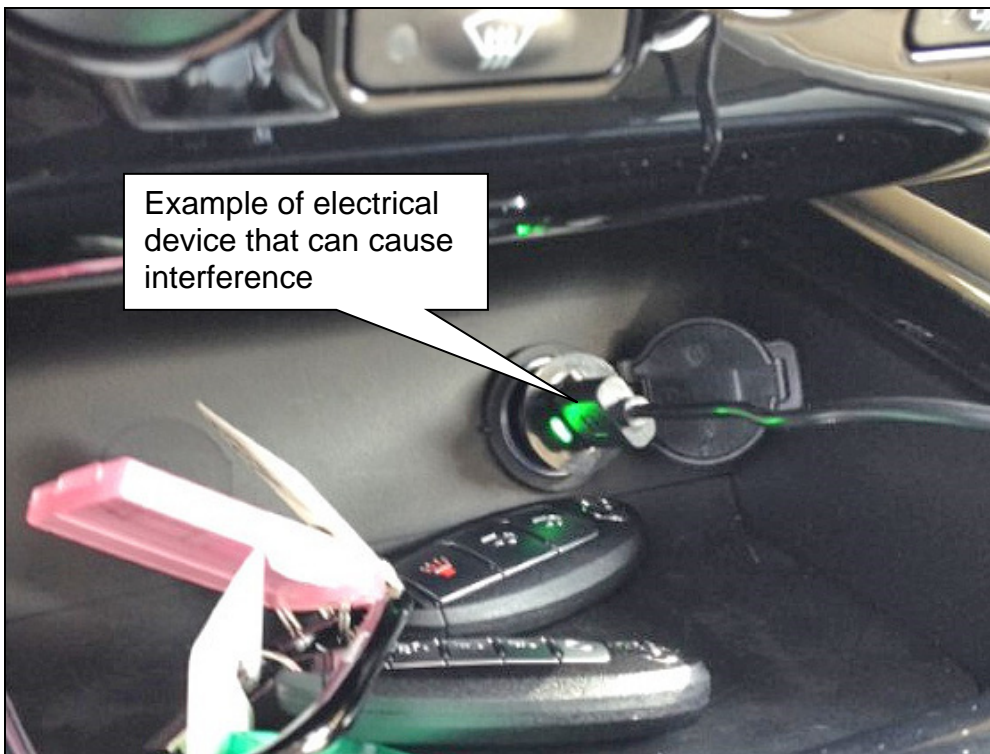
Figure 1

- Intelligent Key fob battery check:
 - Use Signal Tech II **IKEY Battery Test** to confirm battery state of charge.
- Location of Intelligent Key: An Intelligent Key should **not** be stored where the RF signal can be obstructed by nearby metal objects.
- Interference from other personal devices: Confirm the Intelligent Key is not placed in close proximity to phones, other Intelligent Keys, highway PASS Card, USB charger, Personal Computer (PC) charger, etc. that may be transmitting similar RF signals.
 - Technician should remove all devices from vehicle while diagnosing/duplicating the customer issue.
