SERVICE BULLETIN

HA16-008

2014 – 2015 VERSA NOTE POOR HEATER PERFORMANCE WITH AMBIENT TEMPERATURE BELOW -20°C (-4°F)

APPLIED VEHICLE: 2014 – 2015 Versa Note (E12)

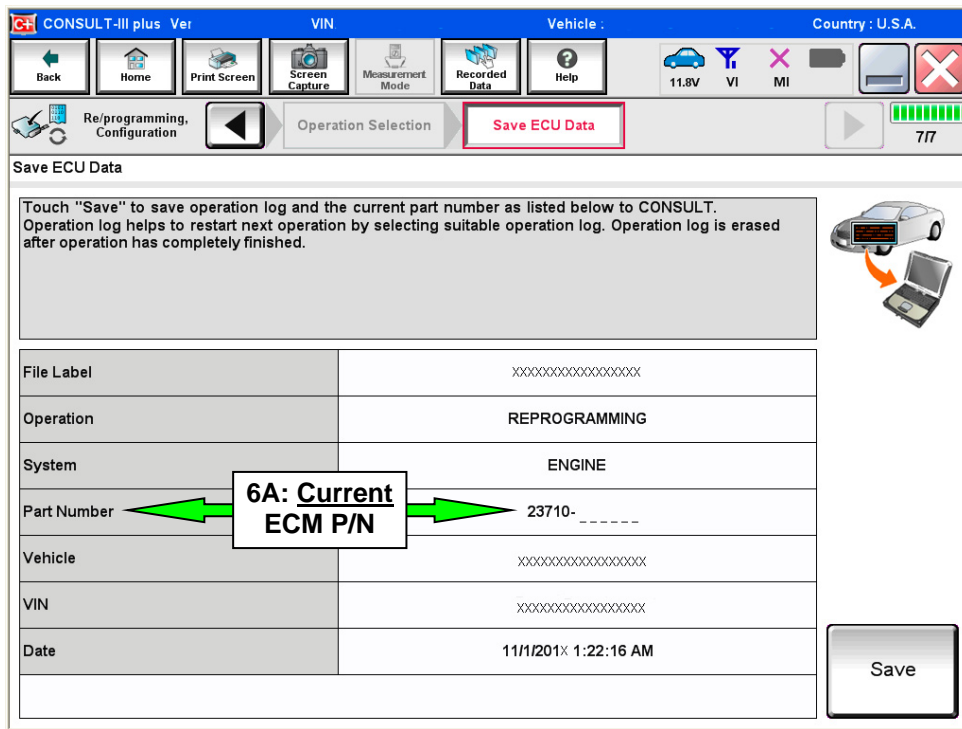
Figure 2

6. When you get to the screen shown in Figure 2, confirm this bulletin applies as follows.

A. Find the ECM **Part Number** and write it on the repair order.

B. Compare the P/N you wrote down to the numbers in the **Current ECM Part Number** column in **Table A** below.

- If there is a match, continue with the reprogramming procedure.
- If there is not a match, this bulletin does not apply. Refer to ASIST for further diagnostic and repair information

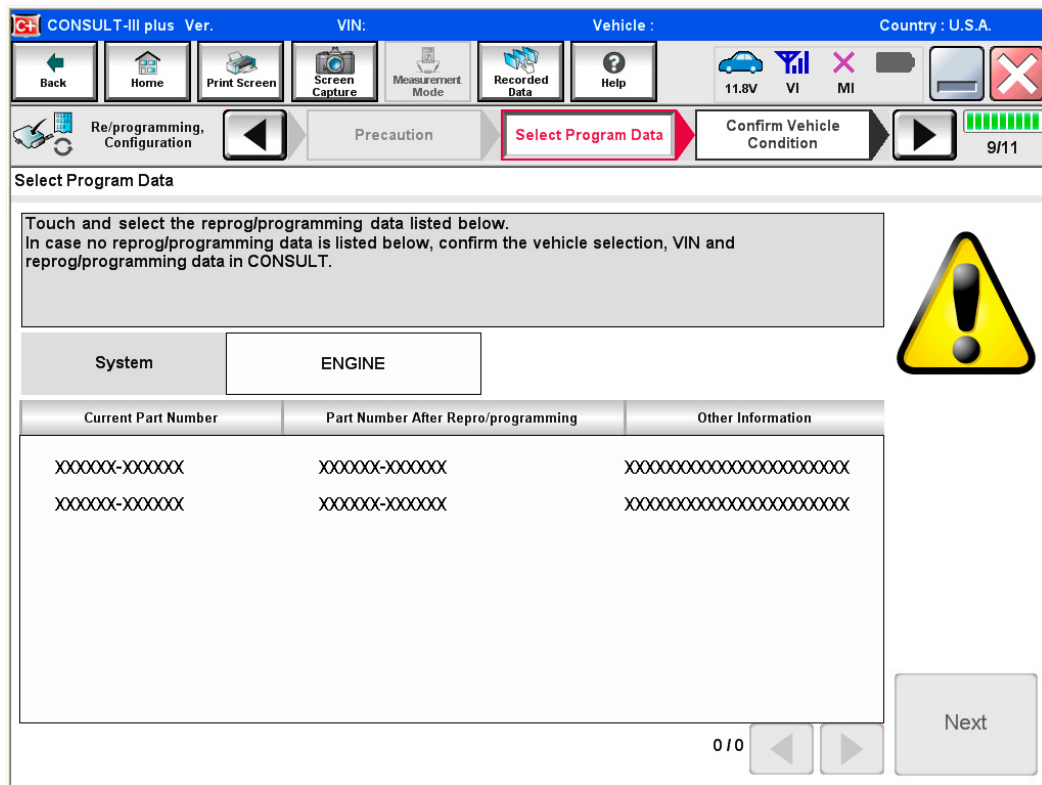
- In some cases, more than one new P/N for reprogramming is available.
 - If there is more than one new P/N, the screen in Figure 3 displays.
 - Select and use the reprogramming option that **does not** have the message “Caution! Use ONLY with NTBXX-XXX”.
- If you get this screen and it is blank (no reprogramming listed), it means there is no reprogramming available for this vehicle.

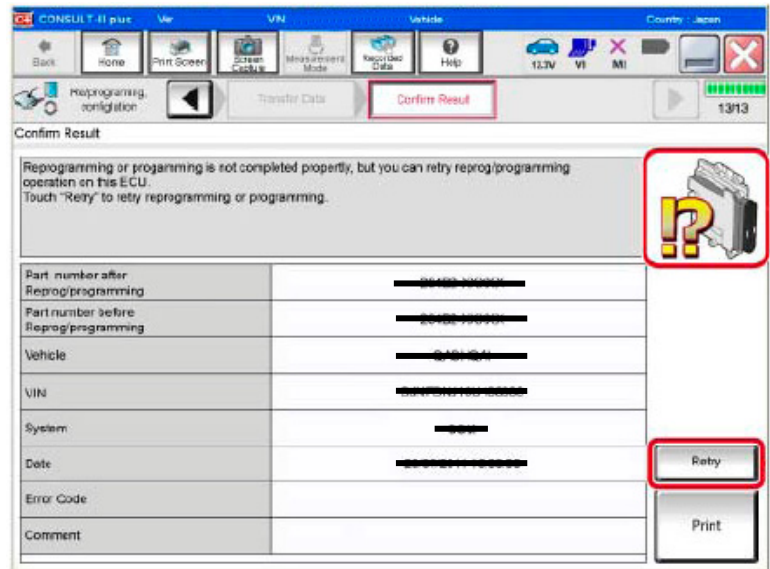
Figure 5

If reprogramming does not complete and the “!” icon displays as shown in Figure 5:

- Check battery voltage (12.0–15.5 V).
- Ignition is ON, engine OFF.
- External Bluetooth® devices are OFF.
- All electrical loads are OFF.
- **Select retry and follow the on screen instructions.**
- “Retry” may not go through on first attempt and can be selected more than once.

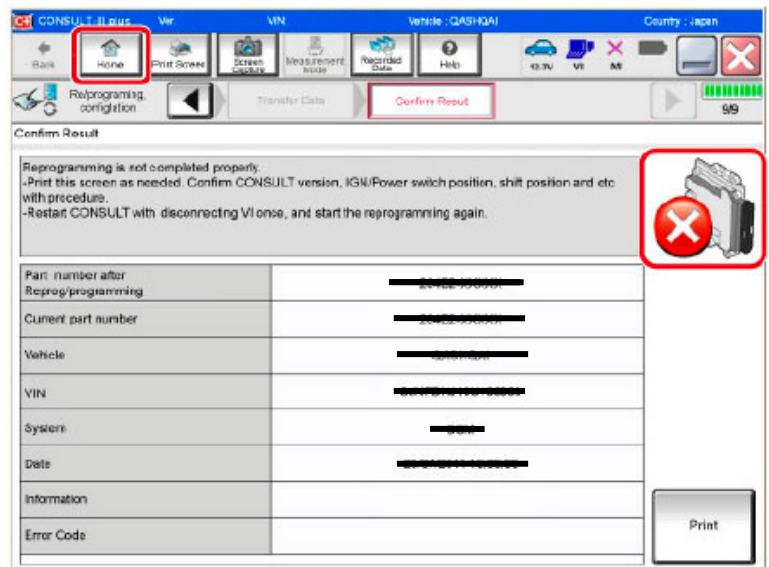
Figure 6

If reprogramming does not complete and the “X” icon displays as shown in Figure 6:

- Check battery voltage (12.0 – 15.5 V).
- CONSULT A/C adapter is plugged in.
- Ignition is ON, engine OFF.
- Transmission is in Park.
- All C-III plus / VI cables are securely connected.
- All C-III plus updates are installed.
- **Select Home, and restart the reprogram procedure from the beginning.**
