# SERVICE BULLETIN Classification: HA16-007 Reference: NTB16-107 November 7, 2016

# 2013 – 2015 SENTRA AND VERSA SEDAN POOR HEATER PERFORMANCE WITH AMBIENT TEMPERATURE BELOW -20°C (-4°F)

APPLIED VEHICLE: 2013 – 2015 Sentra (B17)

2013 – 2015 Versa Sedan (N17)

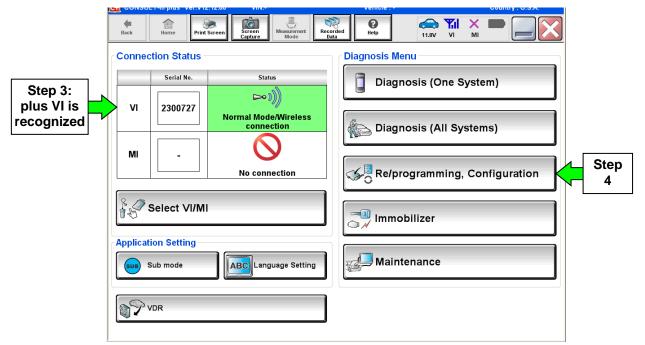
Figure 1

- 1. Connect the CONSULT PC to the vehicle to begin the reprogramming procedure.
- 2 Start C-III plus.
- 3. Wait for the plus VI to be recognized.
  - The serial number will display when the plus VI is recognized.
- 4. Select Re/programming, Configuration.

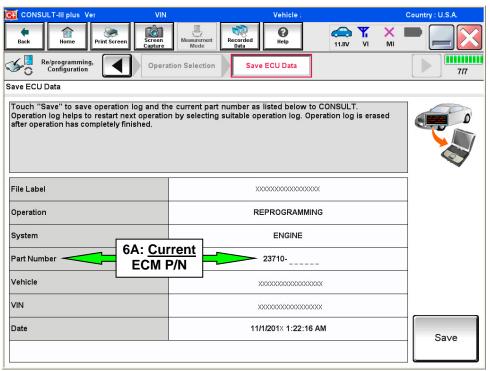
Figure 2

- 6. When you get to the screen shown in Figure 2, confirm this bulletin applies as follows.
  - A. Find the ECM Part Number and write it on the repair order.

**NOTE:** This is the <u>current</u> ECM Part Number (P/N).

- B. Compare the P/N you wrote down to the numbers in the **Current ECM Part Number** column in **Table A** on the next page.
  - If there is a <u>match</u>, continue with the reprogramming procedure.
  - If there is <u>not a match</u>, this bulletin <u>does not apply</u>. Refer to ASIST for further diagnostic and repair information

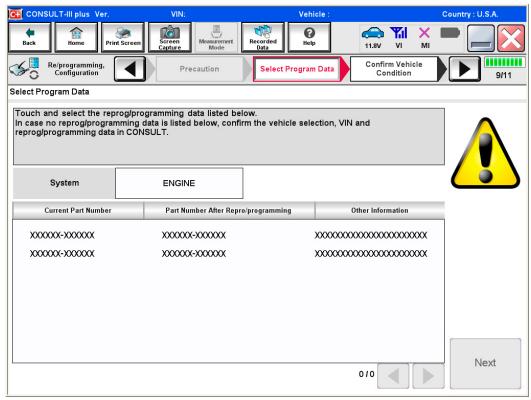
- In some cases, more than one new P/N for reprogramming is available.
  - ➤ If there is more than one new P/N, the screen in Figure 3 displays.
  - > Select and use the reprogramming option that **does not** have the message "Caution! Use ONLY with NTBXX-XXX".
- If you get this screen and it is <u>blank</u> (no reprogramming listed), it means there is no reprogramming available for this vehicle.

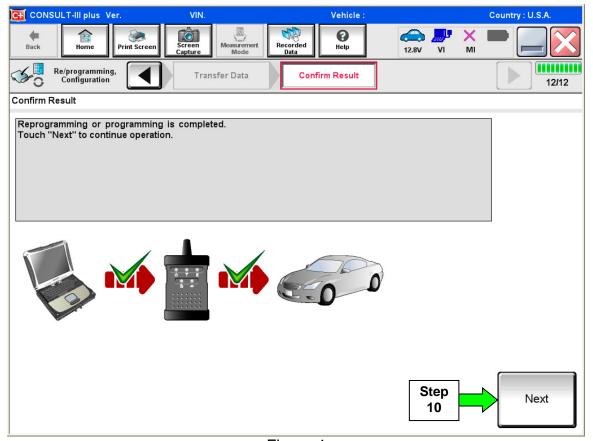
8. When the screen in Figure 4 displays, reprogramming is complete.

**NOTE:** If the screen in Figure 4 does <u>not</u> display (indicating that reprogramming did <u>not</u> complete), refer to the information on page 8.

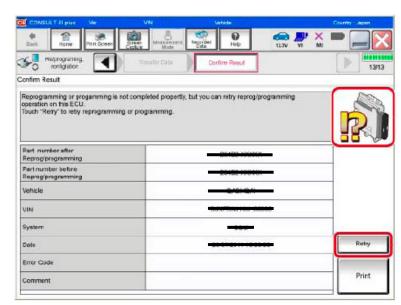
Figure 5

If reprogramming does <u>not</u> complete and the "!?" icon displays as shown in Figure 5:

- Check battery voltage (12.0–15.5 V).
- Ignition is ON, engine OFF.
- External Bluetooth® devices are OFF.
- All electrical loads are OFF.
- Select <u>retry</u> and follow the on screen instructions.
- "Retry" may not go through on first attempt and can be selected more than once.

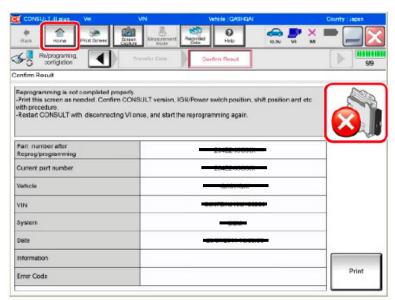
Figure 6

# If reprogramming does <u>not</u> complete and the "X" icon displays as shown in Figure 6:

- Check battery voltage (12.0 – 15.5 V).
- CONSULT A/C adapter is plugged in.
- Ignition is ON, engine OFF.
- Transmission is in Park.
- All C-III plus / VI cables are securely connected.
- All C-III plus updates are installed.
- Select <u>Home</u>, and restart the reprogram procedure from the beginning.

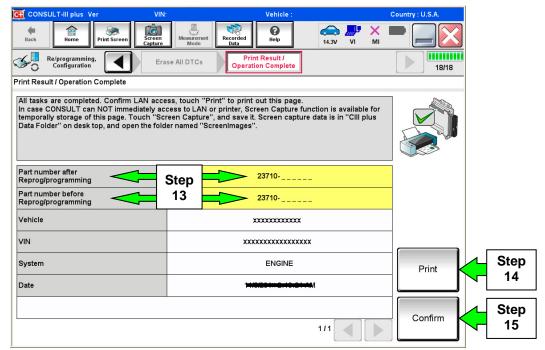
- 12. When the entire reprogramming process is complete, the screen in Figure 7 will display.
- 13. Verify the before and after part numbers are different.
- 14. Print a copy of this screen (Figure 7) and attach it to the repair order for warranty documentation.
- 15. Select Confirm.
