SERVICE BULLETIN

Classification:	Reference:	Date:
AT16-015	NTB16-108	November 14, 2016

2016 TITAN XD; ENGINE RPM FLUCTUATES WHILE DRIVING AT STEADY SPEED

APPLIED VEHICLES: 2016 Titan XD (A61)
APPLIED ENGINE: VK56VD (Gasoline V8)
APPLIED TRANSMISSION: 7AT - RE7R01B

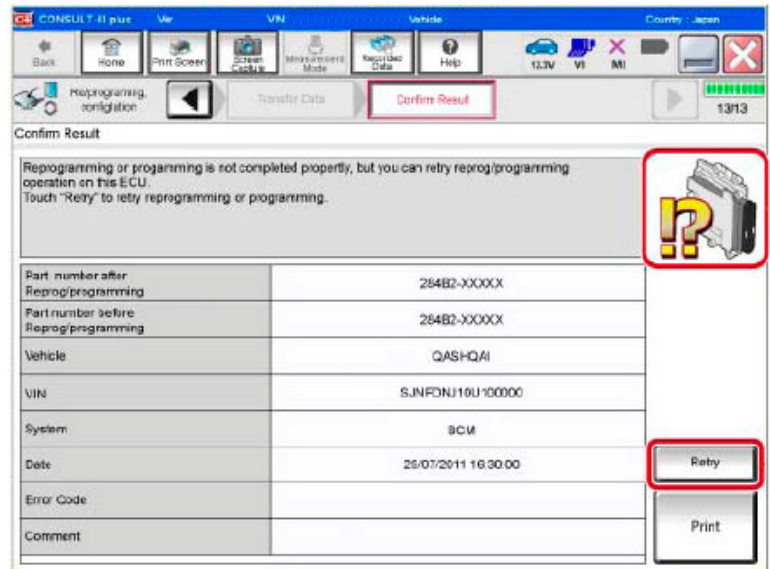
Figure 5

If reprogramming does not complete and the “!” icon displays as shown in Figure 5:

- Check battery voltage (12.0 - 15.5 V).
- Ignition is ON, engine OFF.
- External Bluetooth® devices are OFF.
- All electrical loads are OFF.
- **Select retry and follow the on screen instructions.**
- **“Retry” may not go through on first attempt and can be selected more than once.**

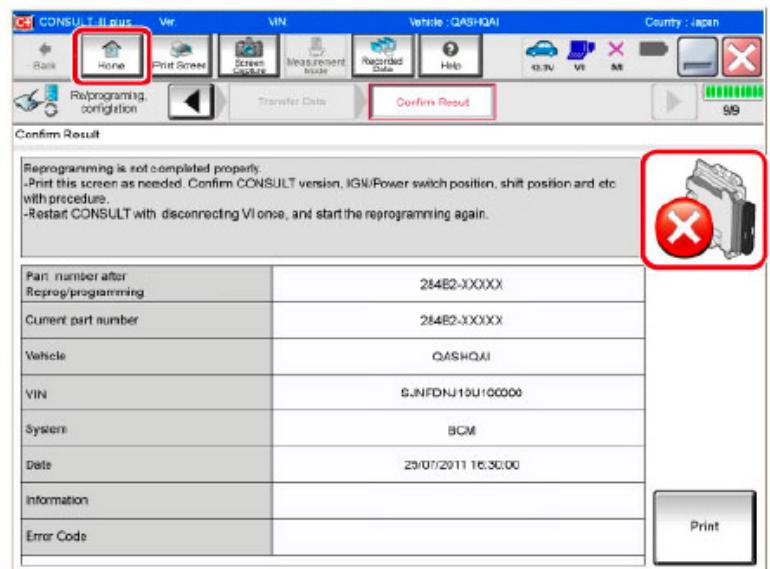
Figure 6

If reprogramming does not complete and the “X” icon displays as shown in Figure 6:

- Check battery voltage (12.0 - 15.5 V).
- CONSULT A/C adapter is plugged in.
- Ignition is ON, engine OFF.
- Transmission is in Park.
- All C-III plus / VI cables are securely connected.
- All C-III plus updates are installed.
- **Select Home, and restart the reprogram procedure from the beginning.**
