Technical Bulletin

SERVICE BULLETIN					
Classification:	Reference:	Date:			
ΔT15-015ο	NTR15-0866	November 14, 2016

2013-2014 ALTIMA AND 2014-2016 ROGUE; MIL ON WITH DTC P0776, P1715 MAY HAVE HESITATION AND/OR LACK OF POWER

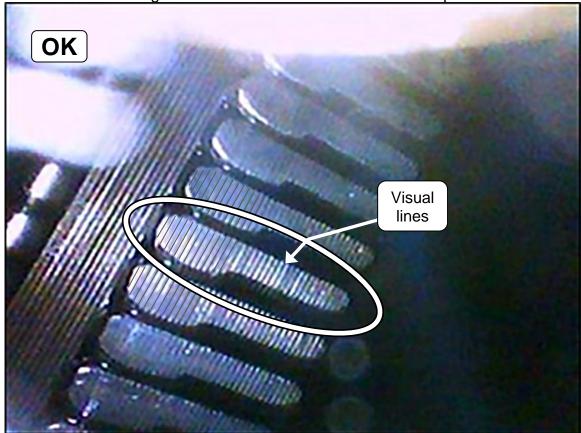
Figure 11: Belt is OK

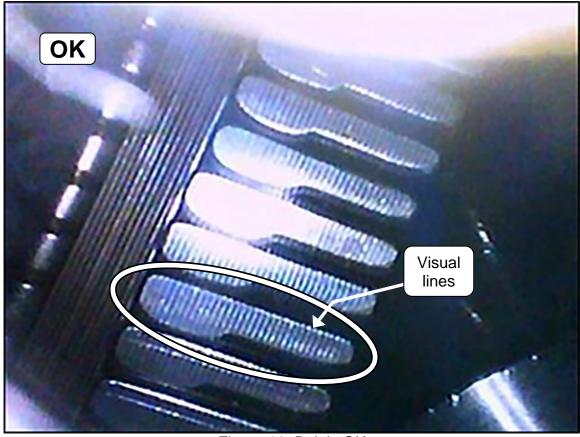
Figure 12: Belt is OK

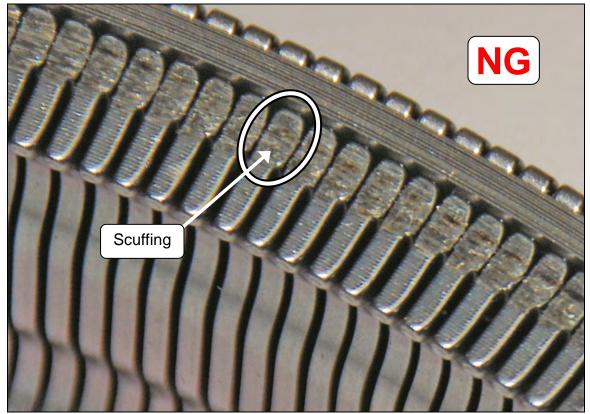
Figure 13: Example of NG belt

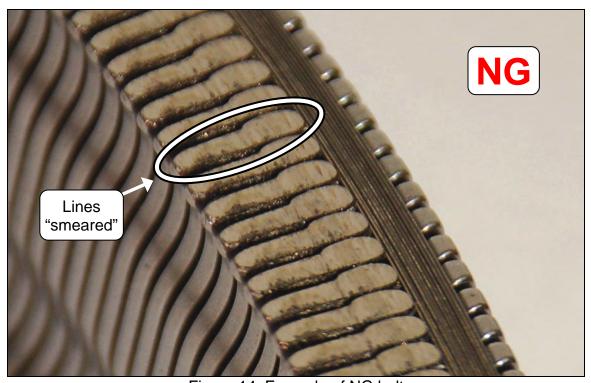
Figure 14: Example of NG belt

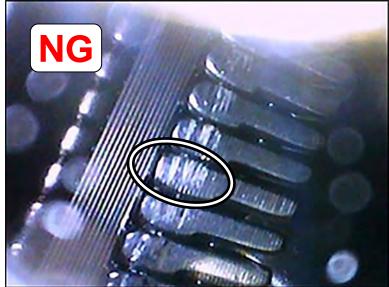
Figure 15: Example of NG belt

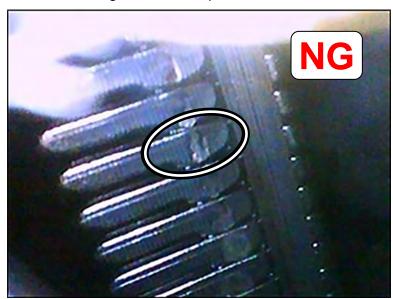
Figure 16: Example of NG belt

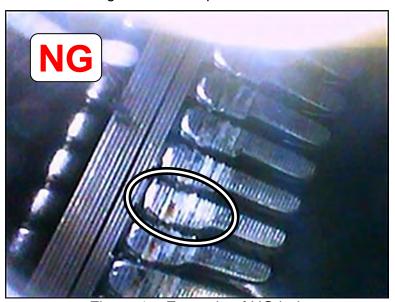
Figure 17: Example of NG belt
