SERVICE BULLETIN

Classification: HA16-004	Reference: NTB16-112	Date: November 15, 2016
-----------------------------	-------------------------	----------------------------

2013-2014 ALTIMA; A/C DOES NOT BLOW COLD AND CLUTCH DOES NOT ENGAGE

APPLIED VEHICLE: 2013-2014 Altima Sedan (L33)

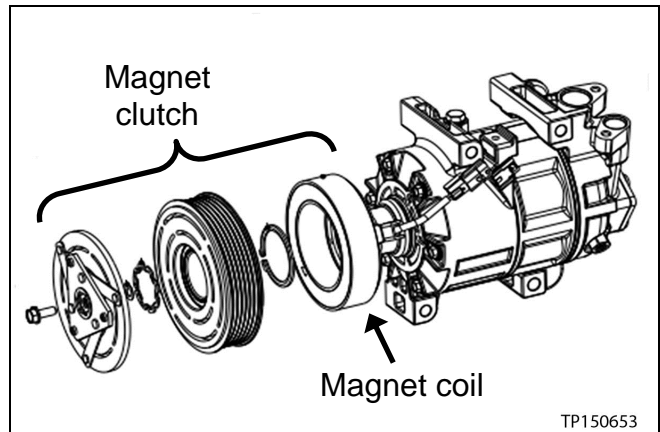
Figure 1

The air conditioner does not blow cold air,

The magnet clutch is determined to be the cause when following the diagnosis procedure in the **HAC** section of the Electronic Service Manual (ESM).

Replace the magnet coil.

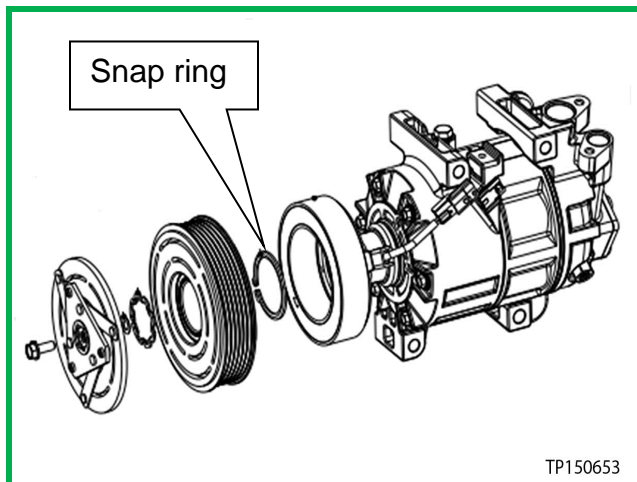
Figure 4

- The magnet coil for the applied vehicles is retained by a single snap ring as shown in Figure 4.
- Figure 5 (and illustrated in the ESM) is incorrect for the applied vehicles. The magnet coil is not attached by three bolts.

1. Replace the CLUTCH COIL ASSY-COMPRESSOR (magnet coil).
 - Refer to the Electronic Service manual (ESM), section **HA – Heater & Air Conditioning System** for replacement information.
 - See page 2 for required tools.

- **Do NOT reuse the bolt or snap rings.**
