**WG39 - Updating Porsche Communication Management (PCM) and Re-programming Instrument Cluster (Workshop Campaign)**

**Model Year:** 2017

**Model line:** Macan (95B)

**Issue:** In the course of annual model improvements, various functionalities of the Porsche Communication Management (PCM) system have been enhanced, optimisations have been implemented and the general performance of the system has been further improved at the same time.

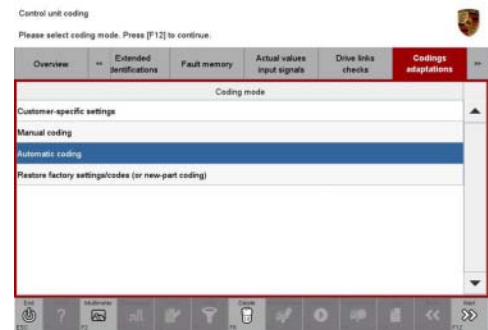
*Automatic coding*

- 2 Select the '**Automatic coding**' function and press •F12" ("Next") to start coding ⇒ *Automatic coding*.

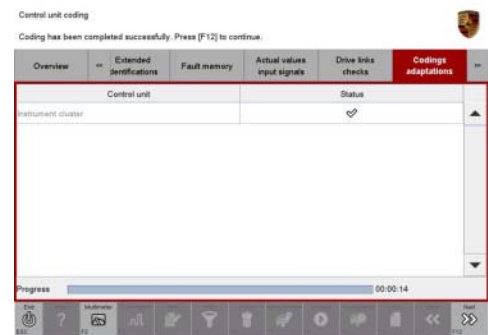
*Coding successful*

- 3 When coding is complete, the message "Coding has been completed successfully" is displayed and a tick appears in the 'Status' box ⇒ *Coding successful*.

If coding is not completed successfully (error message "Coding was not completed successfully"), coding must be **repeated**.

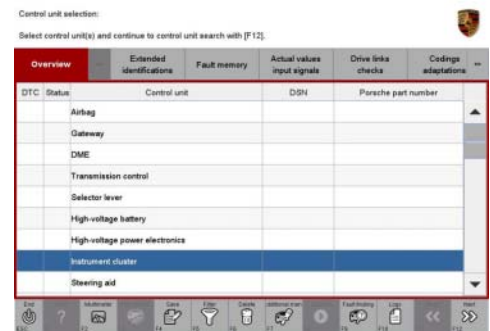
*Control unit selection – Instrument cluster*

- Procedure:
- 1 Select '**Instrument cluster**' in the control unit selection screen ('**Overview**' menu) and press •F12" ("Next") to confirm your selection ⇒ *Control unit selection – Instrument cluster*.
  - 2 Once the instrument cluster has been found and is displayed in the overview, select the '**Codings/adaptations**' menu.
  - 3 Select '**Restore factory settings/codes**' and press •F12" ("Next") to start the process ⇒ *Resetting instrument cluster to factory settings*.
  - 4 Once the settings have been reset successfully, press •F12" ("Next") to continue.
  - 5 Select the '**Overview**' menu and press •F11" ("Back") to return to the control unit selection screen.

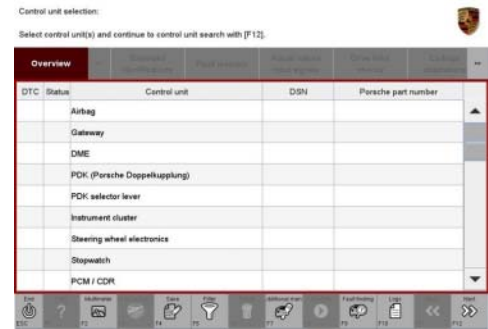
Control unit selection

- Procedure:
- 1 Read out and erase all fault memories.
    - 1.1 In the control unit selection screen ('Overview' menu), press •F7" to call up the 'Additional menu' (⇒ Control unit selection).
    - 1.2 Select the function "Read all fault memories and erase if required" and press •F12" ("Next") to confirm your selection ⇒ Erasing fault memories.

The fault memories of the control units are read out.

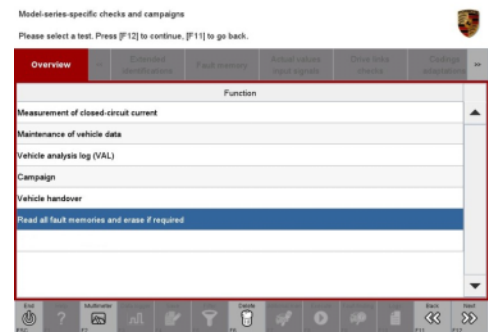
Erasing fault memories

- 1.4 Press •F8" to delete fault memory entries.
- 1.5 Press •F12" ("Yes") in response to the question as to whether you really want to delete all fault memory entries.

The faults stored in the fault memories of the various control units are deleted.
