TECH TIP

Group:	O-GENERAL
Bulletin No:	TT-16-001
Issue Date:	1-19-2016
Reference:	HMM-160119-B1

CONVENTIONAL BCU RESET

SUBJECT VEHICLES: 11MY-14MY Conventional Trucks (238, 258, 268 or 338)

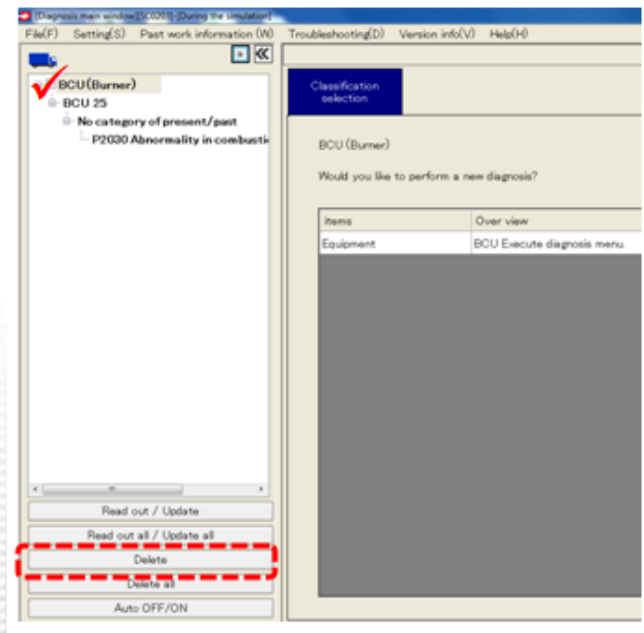
If “BURNER STATE” freezes at: “ - ” or “#0: request (AccumSoot)”

The BCU enters a “waiting mode” if any of the following is recorded during the last ignition cycle: “failed ignition”, “lost flame”, “unable to achieve target temp” or “burner outlet over temp”. This is done to dry diesel fouled igniters. Duration of waiting mode varies according to when the failure occurred. The BCU will wait for 10 minutes after failure during DPR Regen, or 30 minutes after failure during SCR warm-up. Waiting mode can be forcibly reset using DXII.

1. Turn the ignition switch ON.
2. Connect DXII to the BCU.
3. Delete DTCs from the BCU.
4. Close DXII properly by clicking New Diagnosis.
5. Turn the ignition switch OFF.
