# TECH TIP

| Bulletin No: | TT-16-003 |

## DEF PUMP DIAGNOSTIC TIPS

**SUBJECT VEHICLES:** 2011MY-2017MY Hino Conventional Trucks equipped with a J08 engine and 2013MY-2017MY Hino COE Trucks equipped with a J05 engine

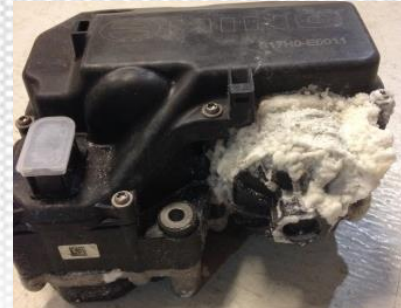
The DEF pump has a serviceable filter. If the filter cap is improperly torqued, a leak around the filter cap, as depicted on the right, may occur. **DO NOT** replace the DEF pump for this condition. This is not a leak from the pump housing. If a leak occurs within the DEF pump, DEF will first come out of the electrical connector. The crystallized DEF can be scraped off and/or dissolved with water. Replace the DEF filter (which includes a new seal) to address this condition.
