# FIELD SERVICE CAMPAIGN BULLETIN

Subject: **Field Service Campaign 16M3**  
**GHG17 DD Platform Model Year 2016 Motor Control Module (MCM)**  
**Replacement**

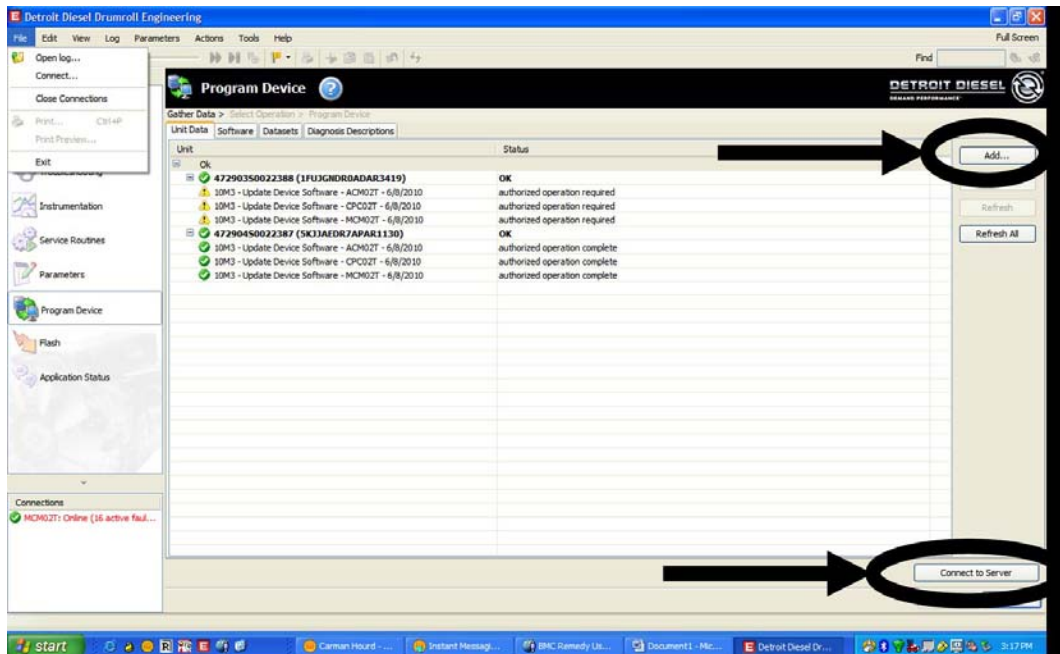
6. Select the “Program Device” option along the left side of the DiagnosticLink<sup>®</sup> screen.
7. Select the “Add” button in the upper right corner of the DiagnosticLink<sup>®</sup> screen and enter the engine serial number. Then click the “Connect to Server” button in the bottom right corner of the DiagnosticLink<sup>®</sup> screen. See Figure 1.

Figure 1 – Adding Engine Serial Number and Connecting To Server
