NUMBER: 08-002-16

GROUP: Electrical

Malfunction Indicator Lamp (MIL) Illumination Diagnostic Trouble Code (DTC) P0113

2015	(BU)	Jeep Renegade
2016	(FB)	Fiat 500X

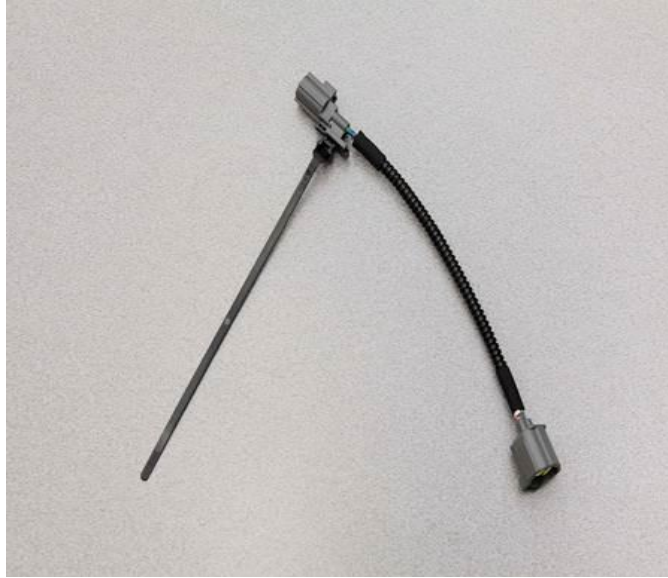
Fig. 1 IAT Jumper

The wiring at the connector of the Intake Air Temperature (IAT) sensor may be compromised due to wire strain causing DTCs. This bulletin involves adding a jumper harness on the IAT sensor to reduce this strain.

Qty.	Part No.	Description
1	68301680AA	Wiring Kit, Jumper

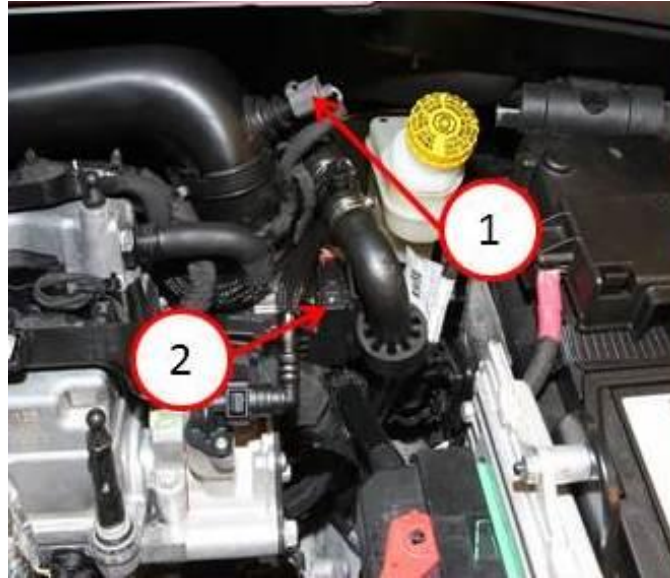
Fig. 2 Location Of IAT Connector

- 1 - IAT Connector
- 2 - Lower Connector

4. Disconnect the IAT and lower connectors, (Fig. 2).

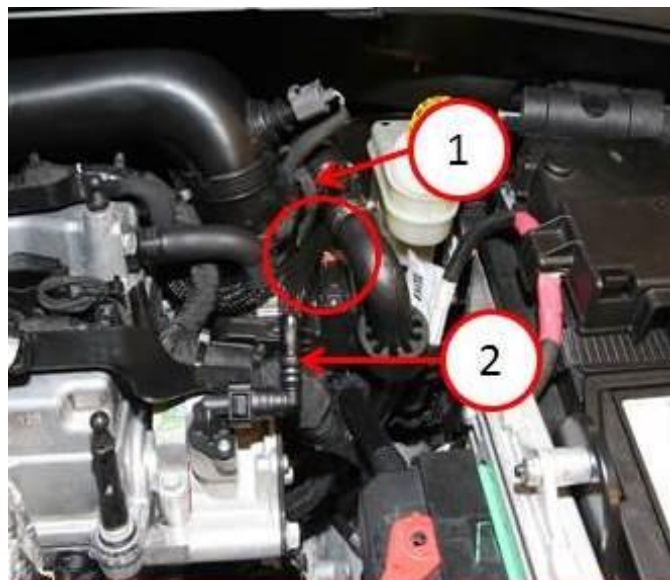
Fig. 3 Route Connectors Under Black Tube

- 1 - IAT harness
 - 2 - Black Tube
-

-
5. Reposition both connectors so that the wires are under the black tube, as shown in (Fig. 3).

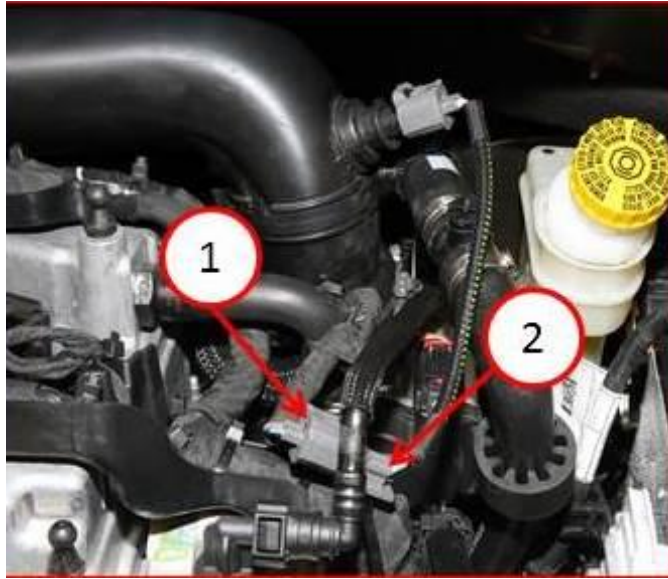
Fig. 4 IAT Jumper And Connector

- 1 - Old IAT Conntor
- 2 - New IAT Connector

6. Reconnect the lower connector.
7. Position the opening of the IAT connector away from the engine, as shown in (Fig. 4).

-
8. Connect one end of the jumper harness to the old IAT connector and then the other end to the IAT sensor.

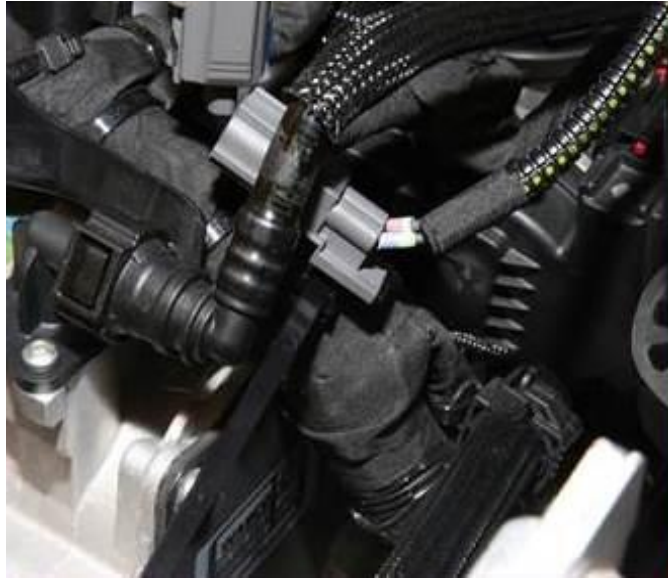
Fig. 5 Location Of Jumper Fastened To Harness

1 - Fasten Jumper On The Main Harness

9. Fasten the jumper harness to the main harness, as shown in (Fig. 5).
