NUMBER: 09-001-16

Headlamp Air Intake Bypass Port Is Capped Off

2016 (LA) Dodge Challenger

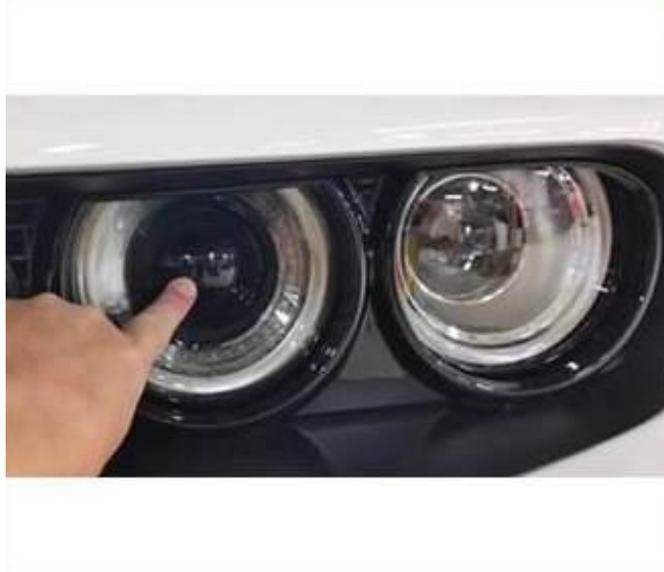
Fig. 1 Air Intake And Headlight Assembly

1. Visually inspect the driver's headlamp assembly for the close out cover as shown in (Fig. 1).

-
2. Is the close out cover present?
 - a. YES>>> Continue with the Repair Procedure.
 - b. NO>>> This Bulletin does not apply. Use Inspection Only LOP (14-10-01-94) to close the active RRT.
 3. Disconnect and isolate the negative battery cable.
