Technical Service Bulletin

19 Dried coolant or small leak around coolant pump

19 16 65 2039018/2 January 20, 2016. Supersedes Technical Service Bulletin Group 19 number 14-53 dated November 18, 2014 for reasons listed below.

Model(s)	Year	VIN Range	Vehicle-Specific Equipment
All	2011 - 2016	All	3.0L engines

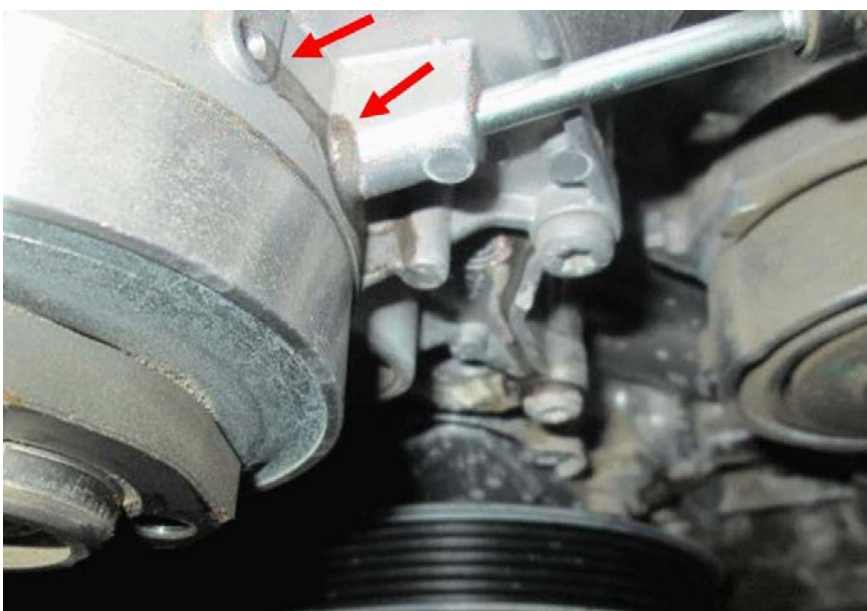
- A small amount of dry or crusted coolant is seen on the coolant pump housing (Figure 1, Figure 2, and Figure 3).
- The coolant level warning is not on.

Figure 1. Dried coolant.

A minor coolant leak is possible during the break-in phase of the coolant seal on the coolant pump. The dry coolant marks are normal.

If dried coolant is found on the coolant pump housing and there is no customer complaint, no repair is necessary. Replacement of the coolant pump is not necessary; a new coolant pump would also show dried coolant during break-in.

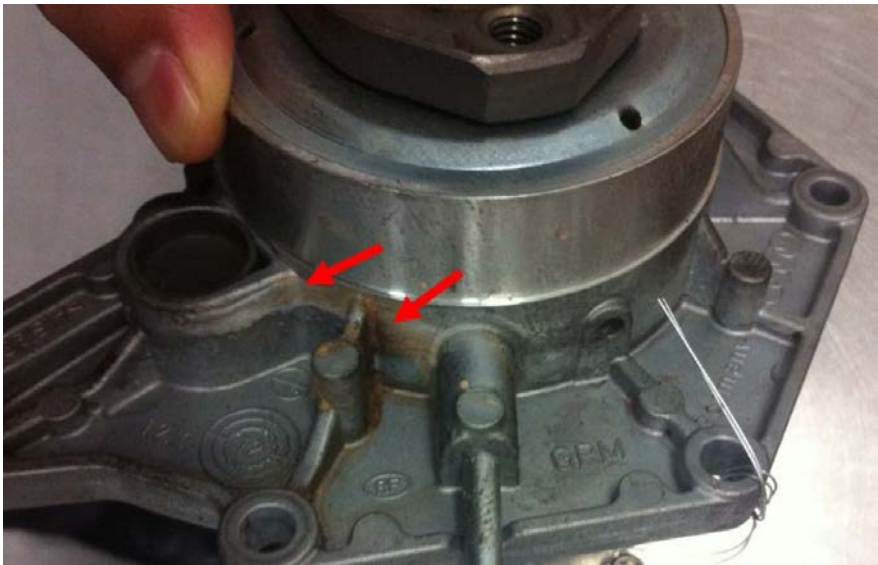
Figure 2. Dried coolant.

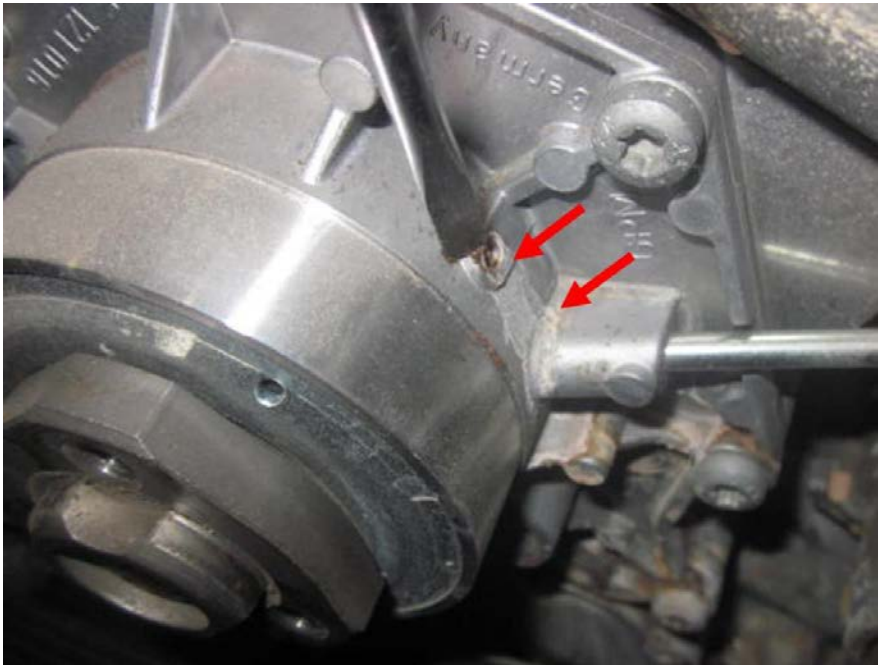
Figure 3. Dried coolant.
