# PREVOST

**WB16-04**

DATE :	FEBRUARY 2016	SECTION :	14 - Steering
EXPIRATION:	FEBRUARY 2018		
SUBJECT :	STEERING DAMPER SECUREMENT

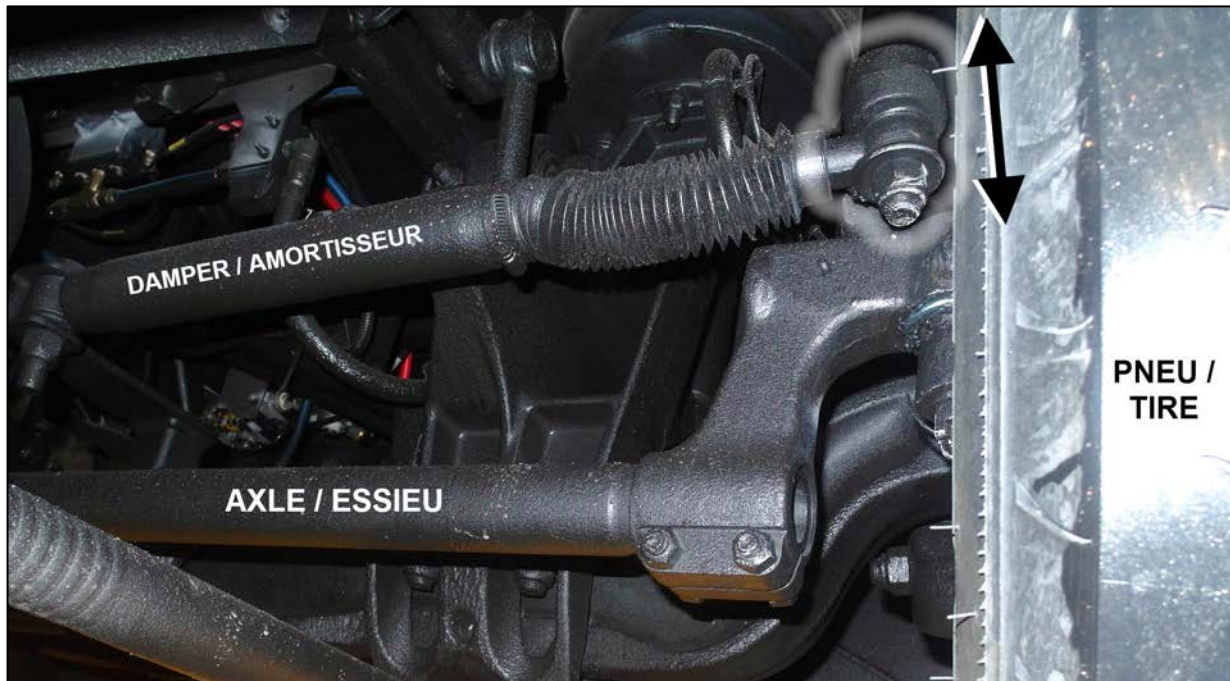
Figure 1

On the vehicles affected by this bulletin the steering damping cylinder rod end spherical bearing may be loose in its housing. Replace as required and secure the steering damper spherical bearing with the provided hardware.

1. Lift vehicle.
2. On front axle the left wheel, locate the steering damper spherical end.(Fig. 1)
3. Make sure there is no vertical play. (Fig. 1)
4. If the spherical bearing moves, replace by a new **660884**.
