**MAINTENANCE
INFORMATION**

Mi12-04C

DATE : MARCH 2012	SECTION : 04 - Exhaust
SUBJECT : WIRING - ACM GROUND AND SUPPLY, DPF TEMP SENSORS, VECU SUPPLY

Rev C: April 12, 2016. Added parts to splice new wire with spare.

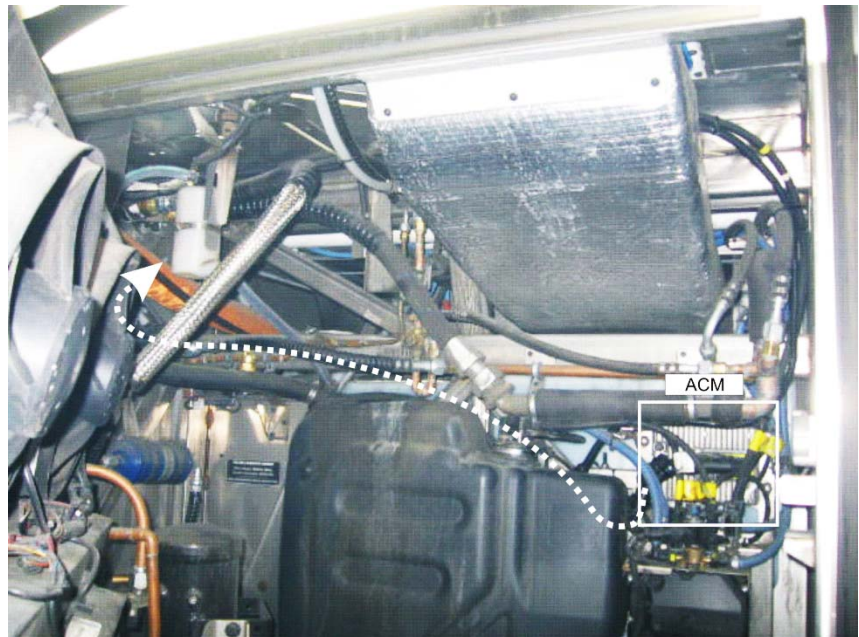
1. Follow existing harness in condenser compartment.

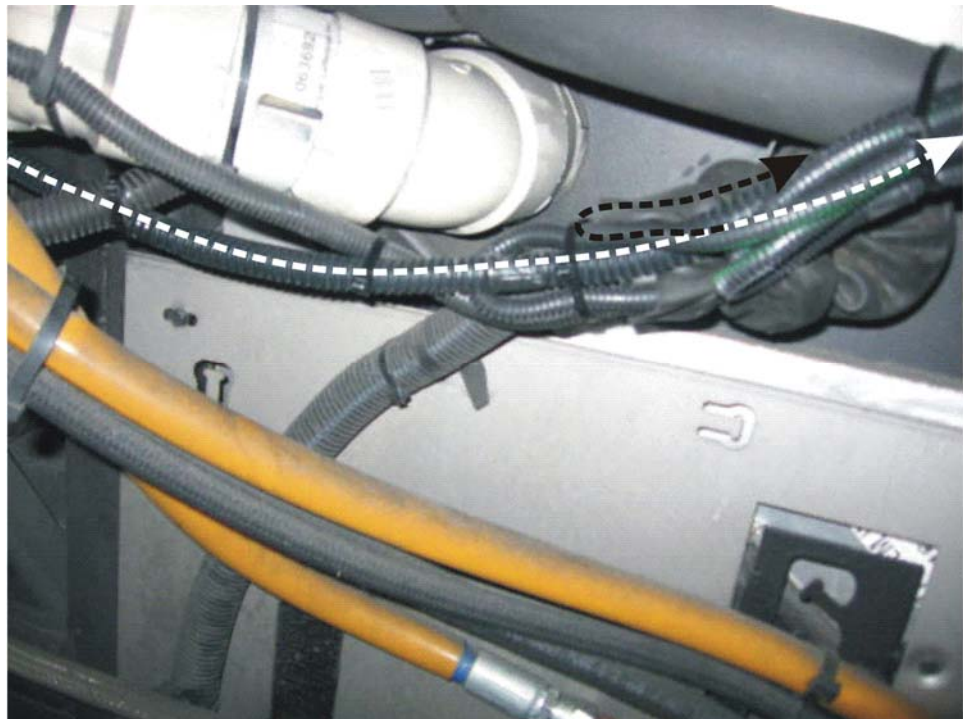
In engine compartment. Accessible through rear access panel inside the coach, close to the restroom. Looking towards the left.

15. Run harness from the tag axle area (previous step) up to the back of the coach following main harness.

Ground cable (black) should be run to the rear electrical compartment.

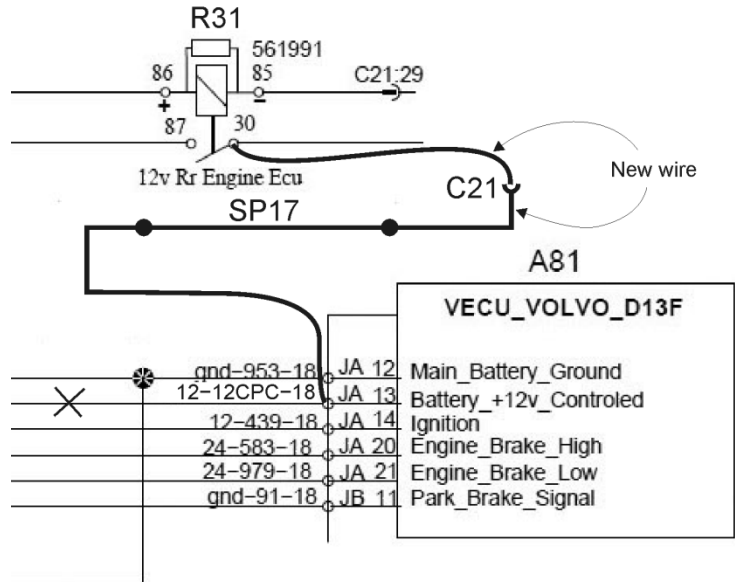
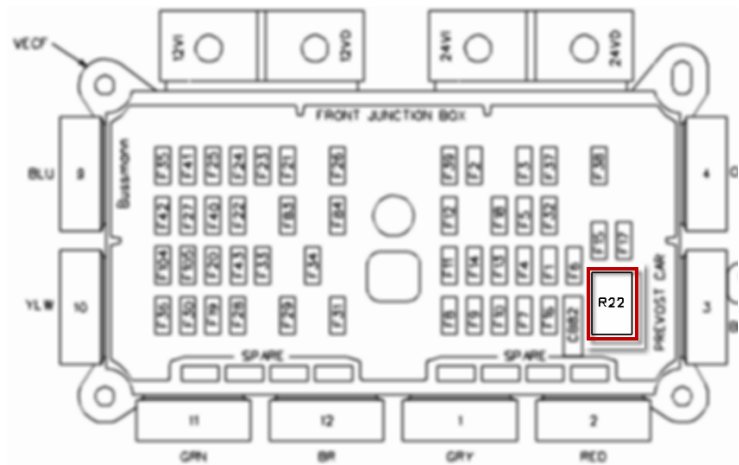
Power supply arrangement to the Vehicle Electronic Control Unit (VECU) may cause recurrent “Vehicle ECU fault” codes in the Driver’s Information Display (DID).

1. In rear electrical compartment, locate **R31**
2. Cut existing tab terminal at pin 30.
3. Crimp new wire #562593 and existing 12ECU wire on #562368 tab terminal. Replace at pin 30 of R31.
4. Install #563588 pin and #563603 socket terminal to pass new wire through C21.
5. (Use extractor tool #682321)
6. Splice new wire end with SP17.
#562228 butt splice
#560784 shrink tube
7. Locate SP17 in front electrical and service compartment it is located near C2.
8. Cut wire 12 CPC at VECU JA13.
9. Run a new 12CPC wire from spare wire SP17 to JA13. Install # 562771 terminal and connect.
10. Once completed, remove R22 Relay from VECF as it is now unused.
