## CHARGING SYSTEM IMPROVEMENT

Prevost vehicles

## APPLICATION

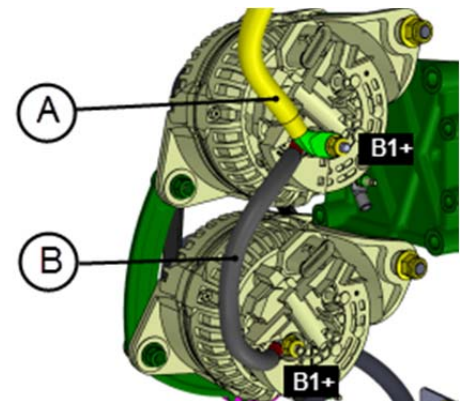
FIGURE 1

A : (+) POWER CABLE

B : (+) JUMPER CABLE

1. Disconnect power cable **A** from the upper alternator **B1+** stud terminal.

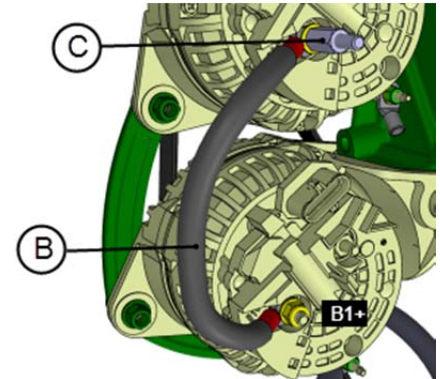
FIGURE 2

B : (+) JUMPER CABLE

C : (+) STUD ADAPTER

2. Disconnect jumper cable **B** from the upper alternator **B1+** stud terminal. To do so, unscrew and remove stud adapter **C** and flat washer.
3. Disconnect jumper cable **B** from the lower alternator **B1+** stud terminal. To do so, remove hex nut and washer.

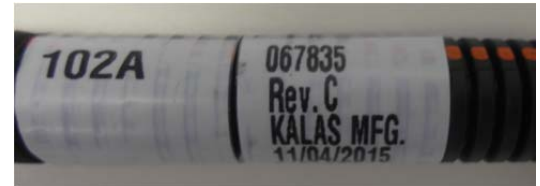
FIGURE 5

Rev.C lug terminal through hole diameter= 5/16" **CORRECT**

Rev.B lug terminal through hole diameter= 13/32" **INCORRECT**

6. Reinstall the jumper cable **#067835 revision C** included in kit #7770176 (FIGURE 5, FIGURE 6).

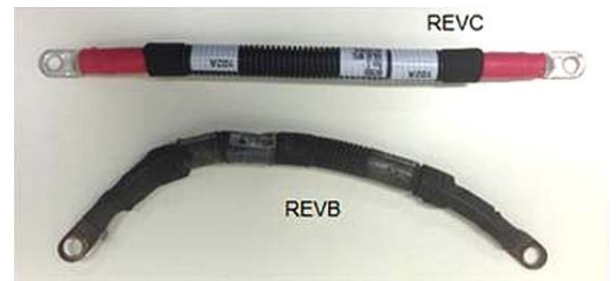
FIGURE 7

*Rev.B diameter of the through hole is too large, reducing contact surface with the stud and the nut thus reducing electrical conductivity between the lug and the alternator stud (FIGURE 7).*

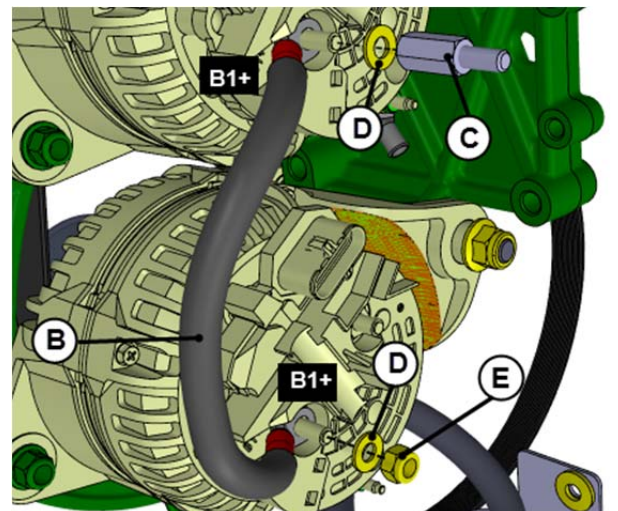
FIGURE 8

**B : JUMPER CABLE #067835 revision C**

**C : STUD ADAPTER #564590 *torque: 10 lbf-ft***

**D: FLAT WASHER #5001341**

**E: NUT M8 #5001787 *torque: 10 lbf-ft***

7. Reinstall appropriate jumper cable **B** (i.e. rev.C) with appropriate stud adapter. Refer to FIGURE 8.

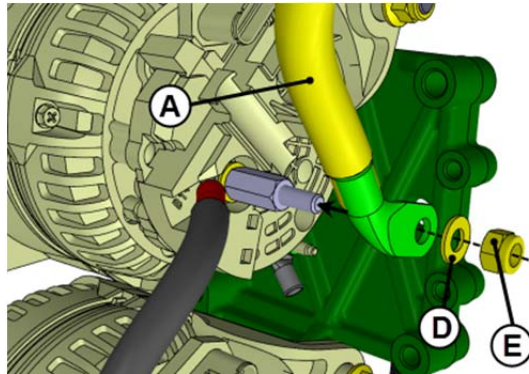
FIGURE 9

A : POWER CABLE

D: FLAT WASHER #5001341

E: NUT M8 #5001787 *torque: 10 lbf-ft*

8. Reinstall power cable **A**. To do so, connect power cable **A** to the upper alternator **B1+** stud terminal. Refer to **FIGURE 9**.

9. **Protect the alternator studs against corrosion.** Apply anti-corrosion compound or **Color Guard Rubber Coating** on alternator terminals, cable lugs and nuts.

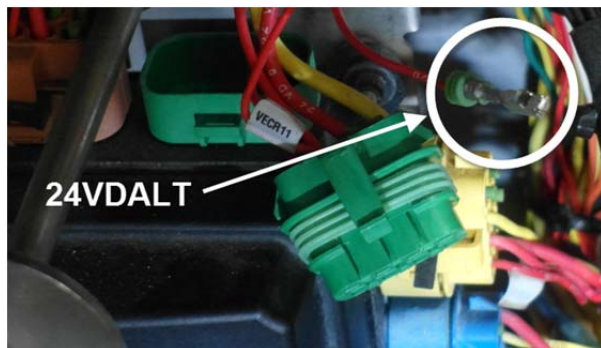
FIGURE 13

FLEXIBLE LOCK TAB LOCATION -  
EXTRACTOR INSERTION POINT

Remove the terminal by disengaging the flexible lock tab on the terminal. Gently remove the terminal from the connector by pulling on the wire.
