## CAC TUBE HANGER REPLACEMENT

Prevost vehicles

On the vehicles affected by this bulletin, improvement of a Charge Air Cooler tube support is required.

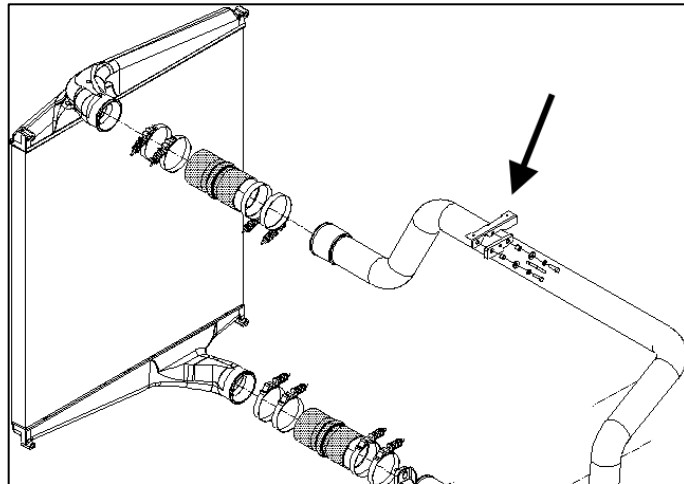
Figure 1

1. Locate this support (arrow, fig. 1) along the top charge air cooler line in the engine compartment.
