# Special Bulletin

# SP16-309A

## CURB SIDE ENGINE DOOR FAN SECUREMENT

Prevost vehicles

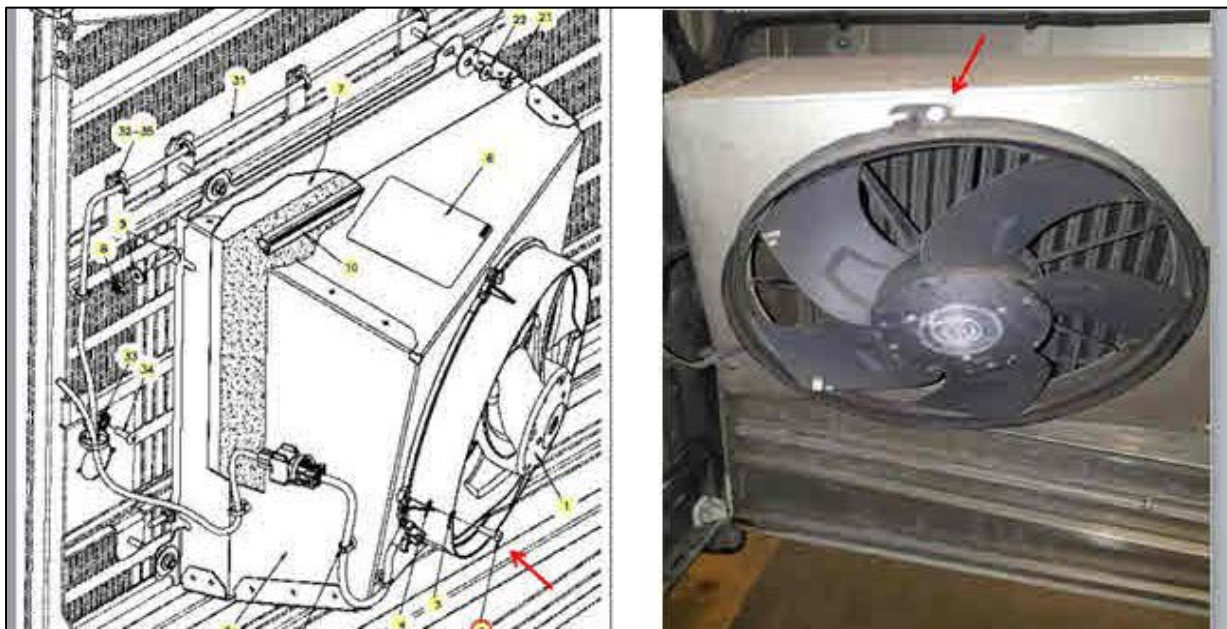
Figure 1

On the vehicles affected by this bulletin, secure the mounting of the curb side engine door electrical fan.

1. Locate the curb side engine compartment door.
2. Locate the fan on the door.

3. Remove fan mounting hardware (4x) one location at a time.
4. Apply Loctite 243 thread locker 685072.
5. Tighten to 7 lbf-ft.
