# Special Bulletin

# SP16-307A

EGR VENTURI TUBE REPLACEMENT

Prevost vehicles

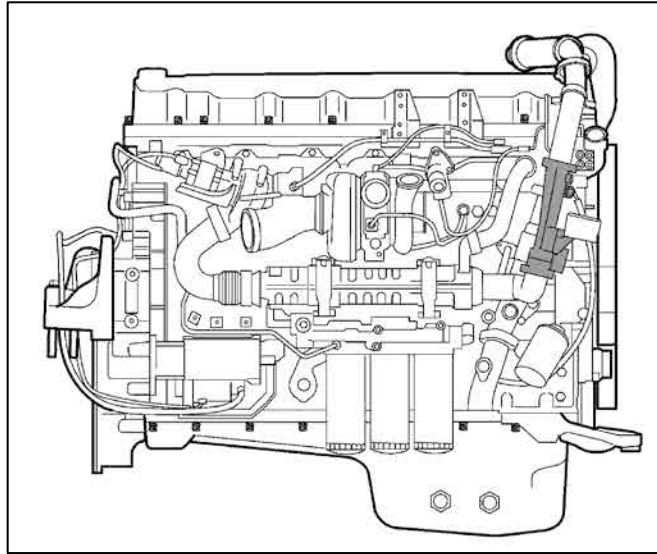
On the hot side of the engine, locate the venturi tube on outlet side of EGR cooler.
