# Special Bulletin

# SP16-316C

FUEL TANK FRAME FRONT SUPPORT WELD

Prevost vehicles

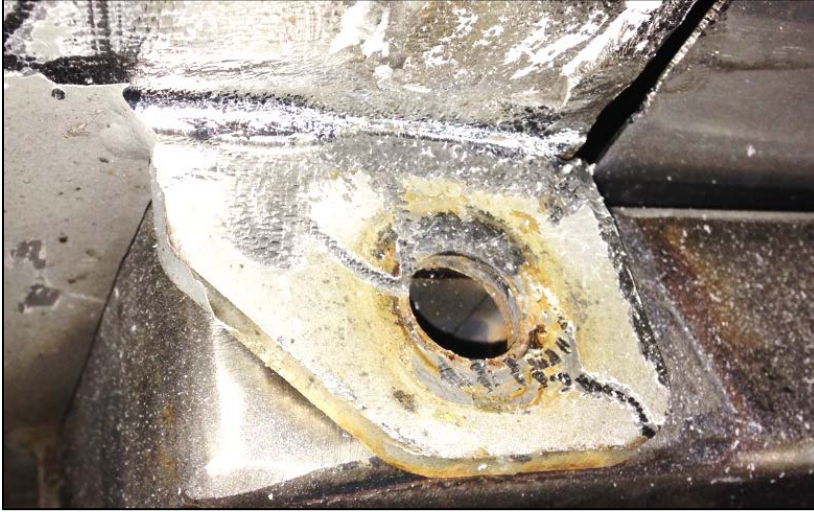
5. Remove tank frame mounting hardware. Reserve for re-use.
6. Remove existing weld on the mounting ears by grinding. (Fig. 3). If a crack is visible, it needs to be cleaned and prepared to a depth that reaches the root of the crack.

Figure 3 Weld removed.

7. Repair according to "Crack Repair" in *Appendix D*. All Weld must meet IT750004 requirement in *Appendix C*.

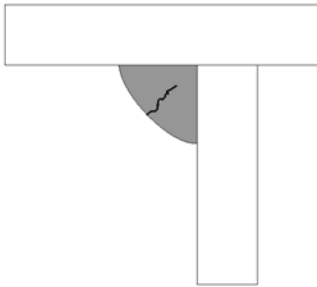
| CRACK REPAIR | | |
|---|---|---|
| Weld cracks on the mounting ears must be grinded to the root and welded. | | |
| If the crack is visible; | | |

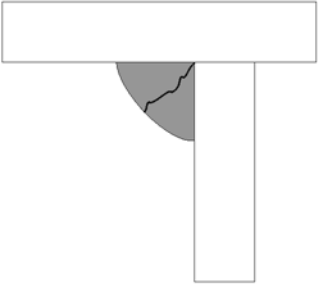
| <p>If grinding reveals that the crack goes all the way through;</p> | |
