# SERVICE BULLETIN

EL16-037

## NAVIGATION FREEZES, BLUETOOTH CALL VOLUME FLUCTUATES, BUTTON ILLUMINATION DIM, OR USB DEVICE NOT RECOGNIZED

**APPLIED VEHICLES:** 2015-2016 Murano (Z52)  
2016 Murano Hybrid (Z52)  
2016 Maxima (A36)

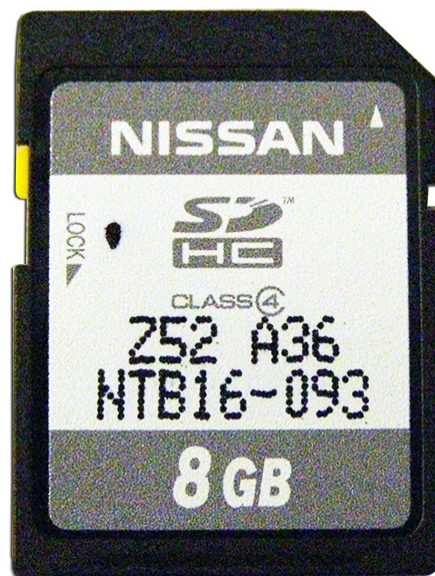
Figure A

- Each dealer has been mailed one software update SD card, free of charge, from Clarion.
- Replacement software update SD cards, due to loss or damage, can be obtained by contacting Clarion: 1-800-347-8933.

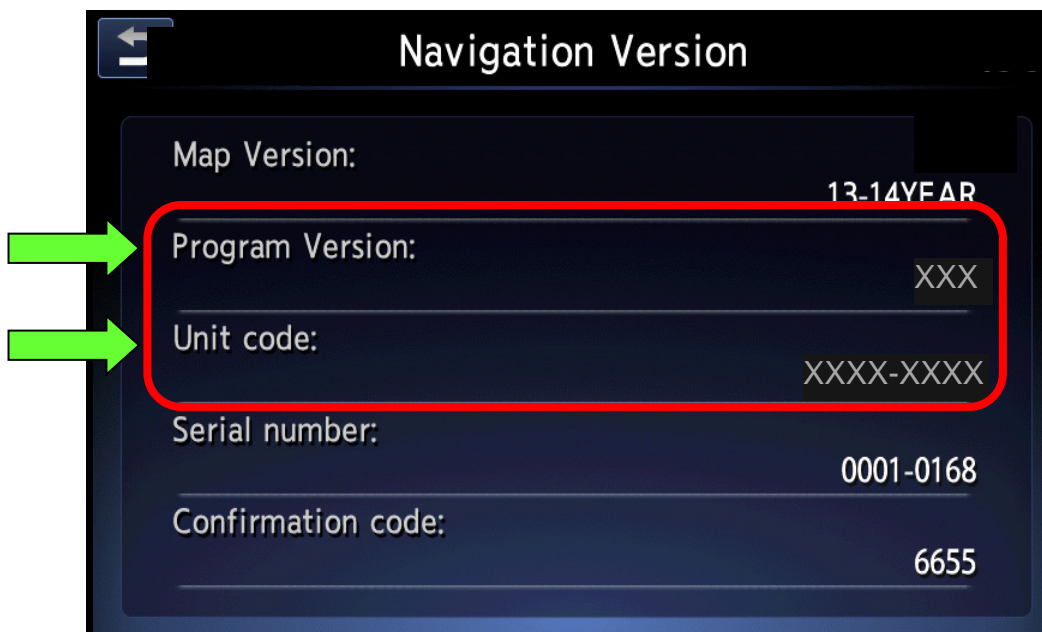
Figure 4

6. Check the **Unit code** and **Program Version** number.

For vehicles with Unit code **QY80-\*\*NA**, **QY80-\*\*NB**, or **QY80-\*\*NC**:

- A software update is needed if the Program Version is not **143**.

For vehicles with Unit code **QY81-\*\*NA** or **QY81-\*\*NB**:

For vehicles with Unit code **QY84-\*\*NA** or **QY84-\*\*NB**:

- A software update is needed if the Program Version is not **564**.

For vehicles with Unit code **QY84-\*\*NC**:

- A software update is not needed.

7. Write down the **Unit code** and **Program Version** values on the repair order and then go to page 5, AV Control Unit Software Update with Software Update SD Card.

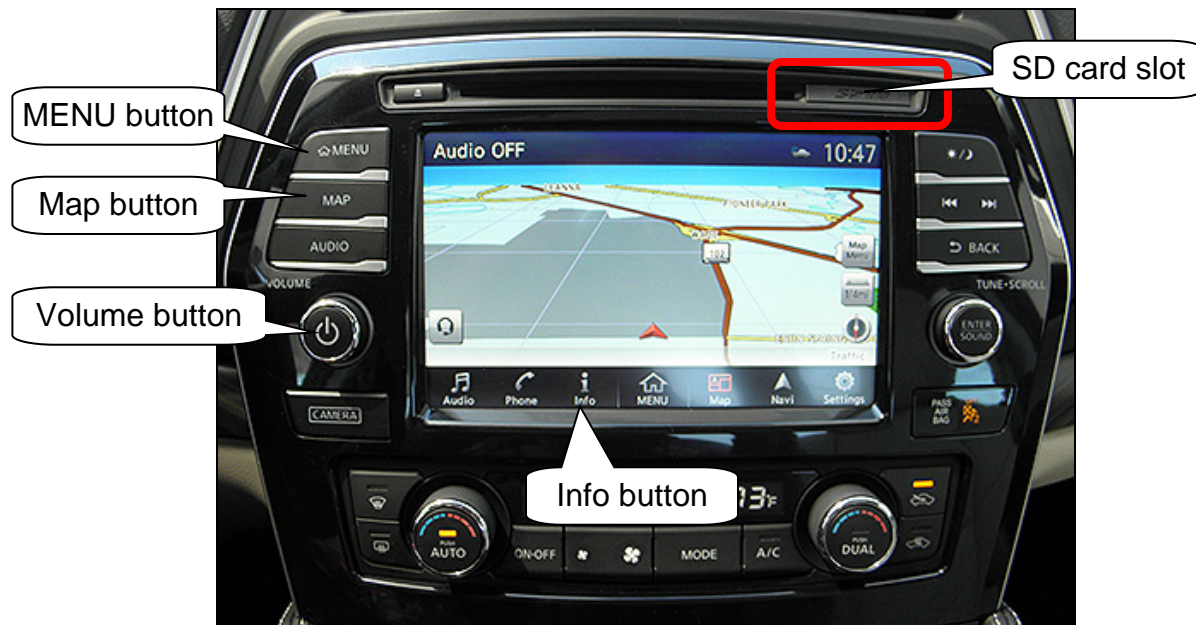
- Refer to Figure 5 below for location of controls and SD card.
- Make sure the MAP SD card (not the software update card) is inserted in the SD card slot before starting the software update procedure.

**CAUTION:** When the ignition is in the ON position, it will power down (turn OFF) automatically after a specific time. To keep from powering down, turn ON the hazard warning lamps (see step 1). Allowing the vehicle to power down during the AV control unit software update may render the AV control unit inoperable.
