# Technical Service Bulletin

## 91 RMC: MMI display missing all text

91 16 32 2043595/1 March 7, 2016.

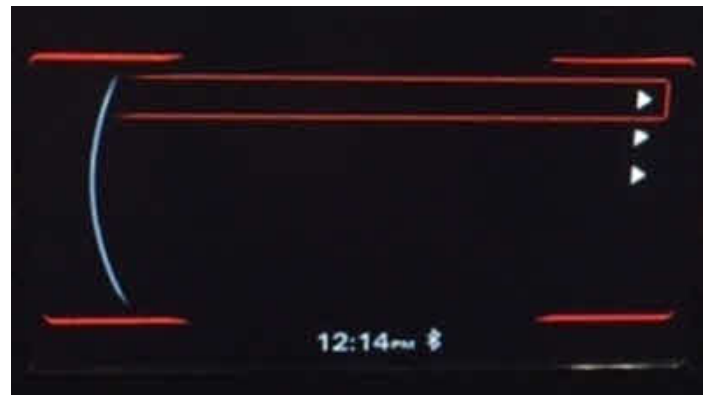
- The customer complains that the display on the MMI screen is incomplete and text is missing (Figure 1 and Figure 2).
- Additionally, the cluster DIS text may be using an incorrect menu language.

Figure 1. MMI car menu missing text.

The RMC main unit is designed to support French, Spanish, and English languages. The control unit software has an issue that can cause the system language to default to German. Because German is not contained in the software, the condition occurs.

- **If the menus change, then a hardware replacement is not needed. The service fix is to allow SVM to configure the RMC main unit again:**
  - Using ODIS, perform the Replacement Test Plan for the 5F using Guided Functions.
  - When prompted, select the option indicating that the old or original part is not available.
  - The test plan must be successful. If any of the SVM portions fail during the process, contact TAC.
- **If the MMI freezes and does not respond when MMI menu change is attempted:**
  - Contact TAC.

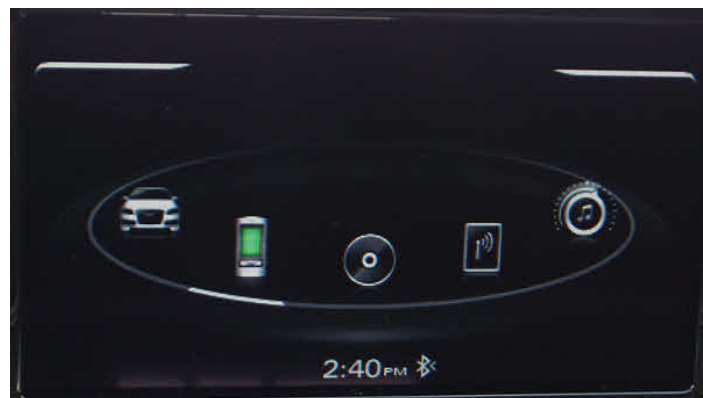
Figure 2. MMI main menu missing text.
