# Audi Elsa Newsletter

Edition 178: March 21, 2016

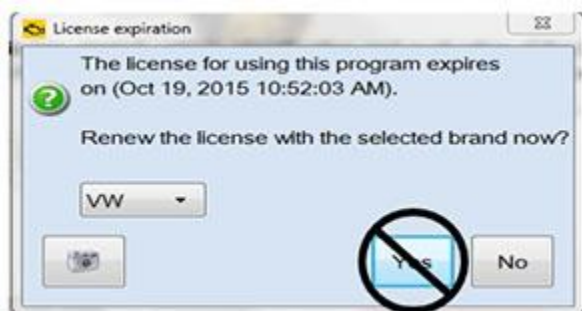
Please be reminded that ODIS Service licenses expire two years after download and installation.

When the License Expiration message and renewal prompt appear, please **DO NOT** select the YES prompt. (Select NO or x-out the window.)

To request and install a new license, please refer to **Service Information – ODIS Service** document **AOS-15-15 License Renewal Instructions**.
