# Audi Elsa Newsletter

Edition 179: March 28, 2016

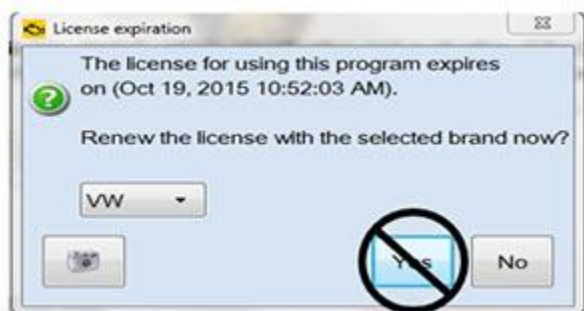
Please be reminded that ODIS Service licenses expire two years after download and installation.

When the License Expiration message and renewal prompt appear, please **DO NOT** select the YES prompt. (Select NO or x-out the window.)

To request and install a new license, please refer to **Service Information – ODIS Service** document **AOS-15-15 License Renewal Instructions**.
