## SERVICE BULLETIN

**APPLICABILITY:** All 2012 to 2015 Models Equipped with Fujitsu Ten (F10) Generation 1 (Gen1) Audio / Navigation Systems

**NUMBER:** 15-193-16

**SUBJECT:** New SD Card Software Update Procedure

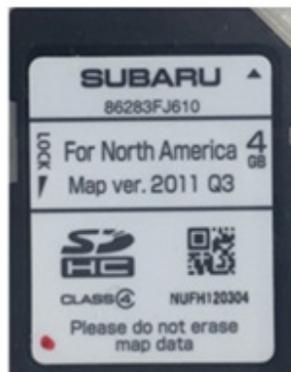
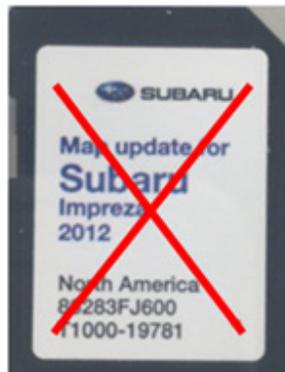
**NOTE:** This procedure is NOT to be used for updating Map update cards as shown here with a red "X". To update the software on a Map Update card, the customer must to contact HERE for assistance at: 1-866-462-8837 (M-F 8AM-6PM CST).

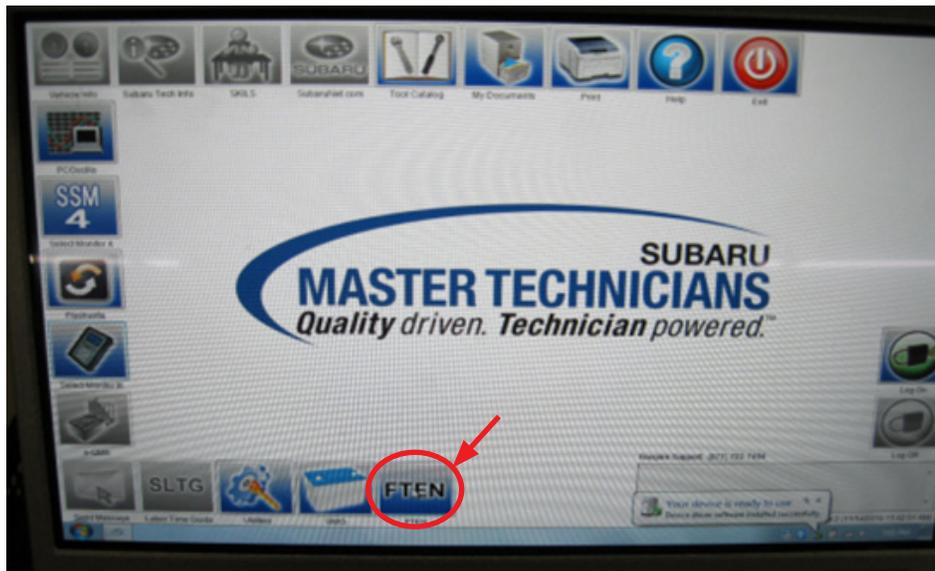
Before proceeding, confirm the “FTEN” icon is displayed on the Select Monitor GUI screen as shown below. If the FTEN icon is not displayed, verify the SSM software version currently installed on the PC being used. If your system does not have the October, 2015 or newer software version installed, contact Nuspire at: 1-877-782-7404 to request the update.

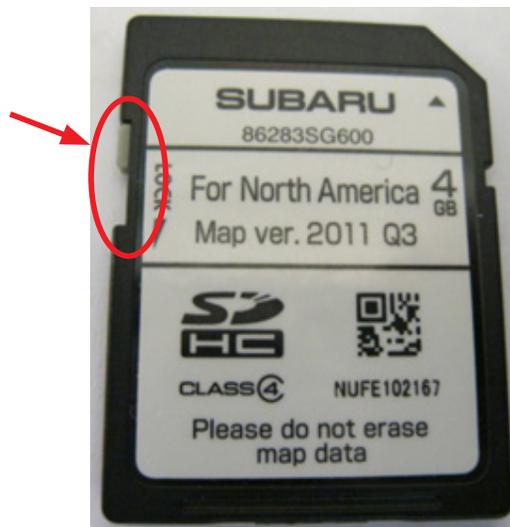
- Confirm the ignition key (or Push Start switch) is in the “OFF” position.
- Remove the PDI fuse from the Main Box (M/B under-hood fuse box). Confirm the audio system will no longer power up with the key in the accessory position before proceeding. If it still powers on, the incorrect fuse was removed from the M/B.
- Using your finger, lightly press the SD Card inward and then release to eject it from the head unit.
- Confirm the lock tab is in the “up” or “unlocked” position as shown below.

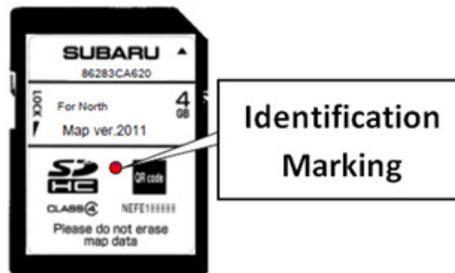
- Using a permanent marker, place a dot on the face of the SD card as shown in the illustration to identify it as being updated.
